Facility Condition Assessment Summary Report

Cook-Wissahickon School

School District of Philadelphia
S641001;Cook-Wissahickon
Final
Site Assessment Report
January 31, 2017

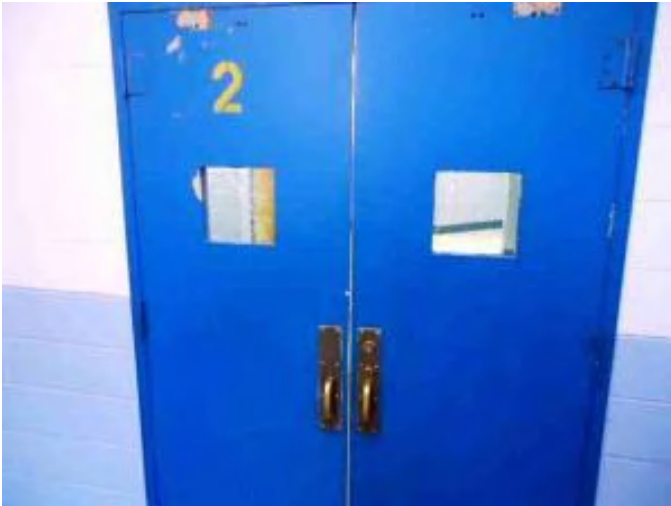
System: C1010 - Partitions

Location: Stairs
Distress: Damaged
Category: 3 - Operations / Maint.
Priority: 1 - Response Time (< 2 yr)
Correction: Install fire rated walls and door where required - insert number of doors
Qty: 12.00
Unit of Measure: S.F.
Estimate: \$63,053.29
Assessor Name: Ed Davis
Date Created: 02/16/2016

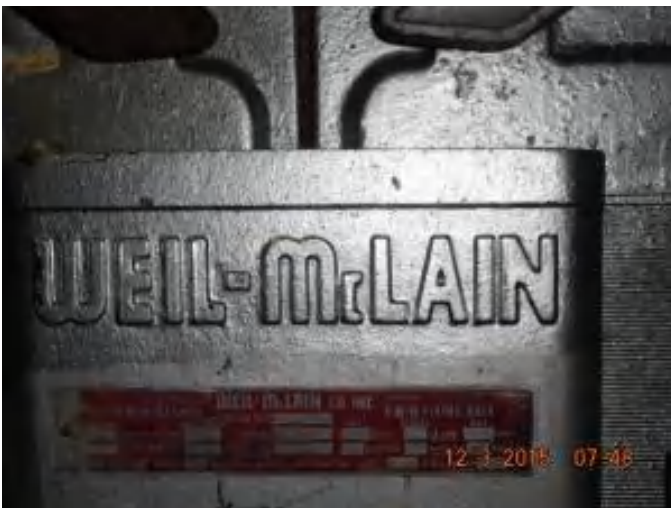
System: D3020 - Heat Generating Systems

The boilers were installed in 1969 should be replaced based on excessive service life. The unit ventilators and air handling units should be replaced based on age and condition and to provide code required outside air quantities. The distribution piping, heat exchanger and pumps are in poor condition, have exceeded the service life and should be replaced. The chiller has remaining service life of twenty years and the cooling tower ten years.

Location: mechanical room
Distress: Beyond Service Life
Category: 3 - Operations / Maint.
Priority: 1 - Response Time (< 2 yr)
Correction: Replace boiler, cast iron sectional (150 HP)
Qty: 2.00
Unit of Measure: Ea.
Estimate: \$1,012,205.26
Assessor Name: Ed Davis
Date Created: 02/19/2016

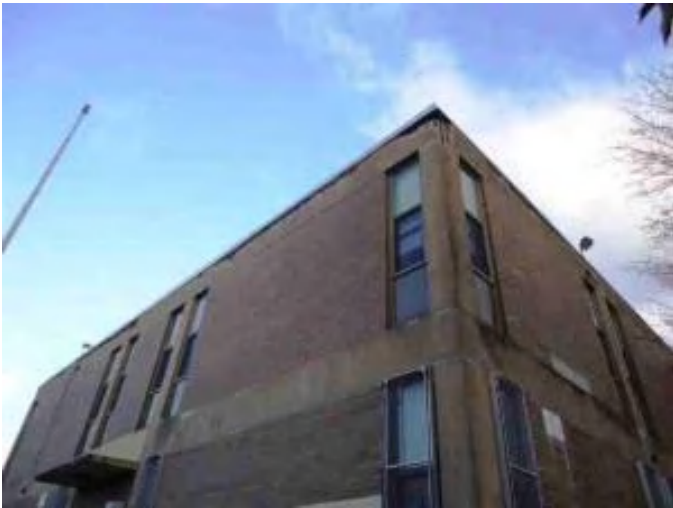
System: B2010 - Exterior Walls

The exterior concrete finish is spalling as indicated in the photos. Thus far the damage is building wide around the concrete framing of the exterior brick finish. This deficiency provides a budgetary consideration for repairs to the concrete sections that are damaged. This work should be coordinated with the recommended exterior point and tuck work.

Location: Exterior Elevation
Distress: Damaged
Category: 3 - Operations / Maint.
Priority: 2 - Response Time (2-3 yrs)
Correction: Repair spalled concrete wall structure
Qty: 20,000.00
Unit of Measure: S.F.
Estimate: \$1,134,324.24
Assessor Name: Ed Davis
Date Created: 02/16/2016

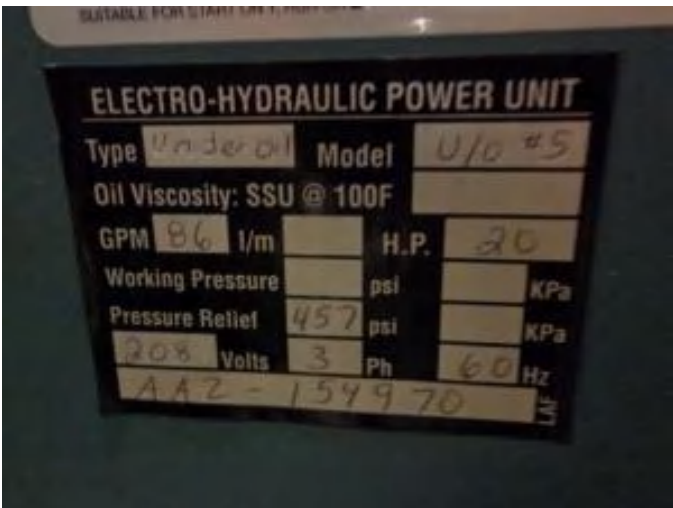
System: D1010 - Elevators and Lifts

Location: Mechanical Room 024
Distress: Beyond Service Life
Category: 3 - Operations / Maint.
Priority: 2 - Response Time (2-3 yrs)
Correction: Replace Elevator - 2 to 3 stop hydraulic - add to the estimate for the number of stops over 2 up to 3 stops total - for 4 stops and up use traction elevator
Qty: 1.00
Unit of Measure: Ea.
Estimate: \$314,091.20
Assessor Name: Ed Davis
Date Created: 01/24/2016

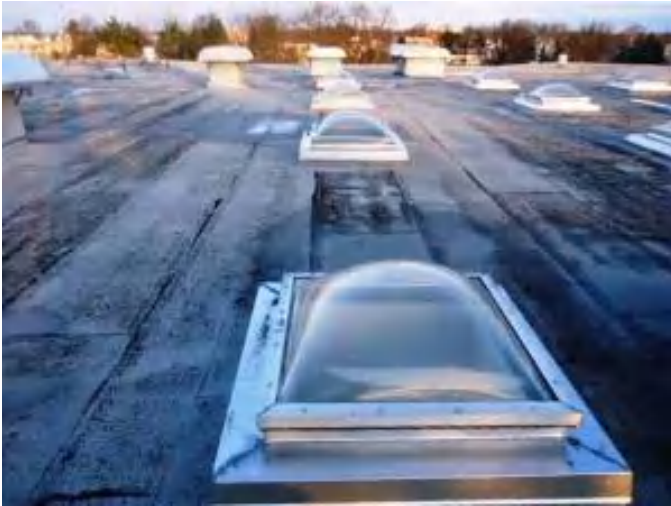
System: B3010105 - Built-Up

The roof is a built up application that was installed in the early 1990's. Considering the age and condition of the roofing systems, universal upgrades are recommended. This deficiency is expected to be completed as part of an exterior effort coordinated with other recommendations included in this report.

Location: Roof

Distress: Damaged

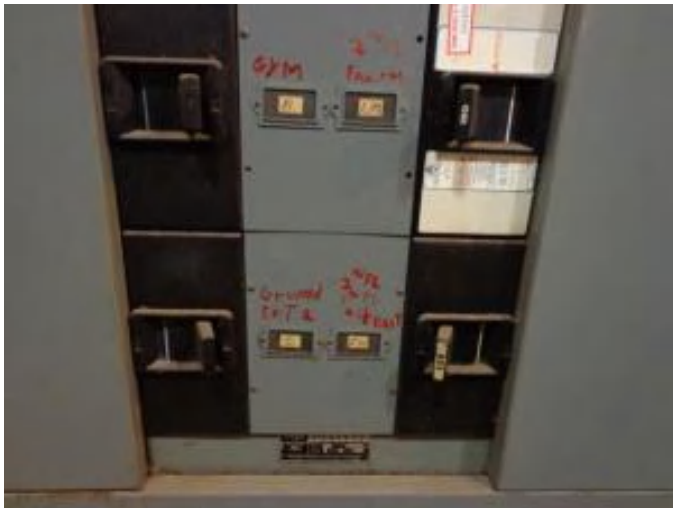
System: D5010 - Electrical Service/Distribution

Location: Mechanical Room 019
Distress: Beyond Service Life
Category: 3 - Operations / Maint.
Priority: 3 - Response Time (3-4 yrs)
Correction: Replace unit substation
Qty: 1.00
Unit of Measure: Ea.
Estimate: \$607,230.55
Assessor Name: Ed Davis
Date Created: 01/24/2016

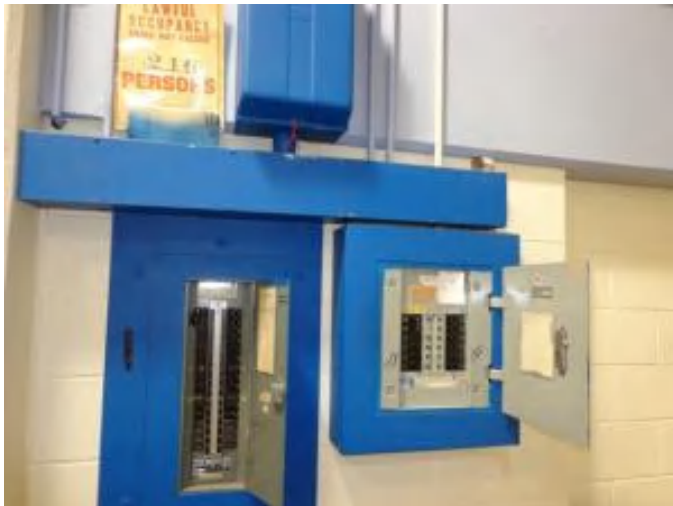
System: D5010 - Electrical Service/Distribution

Location: Building wide
Distress: Beyond Service Life
Category: 3 - Operations / Maint.
Priority: 3 - Response Time (3-4 yrs)
Correction: Replace Panelboard
Qty: 12.00
Unit of Measure: Ea.
Estimate: \$317,322.83
Assessor Name: Ed Davis
Date Created: 01/24/2016

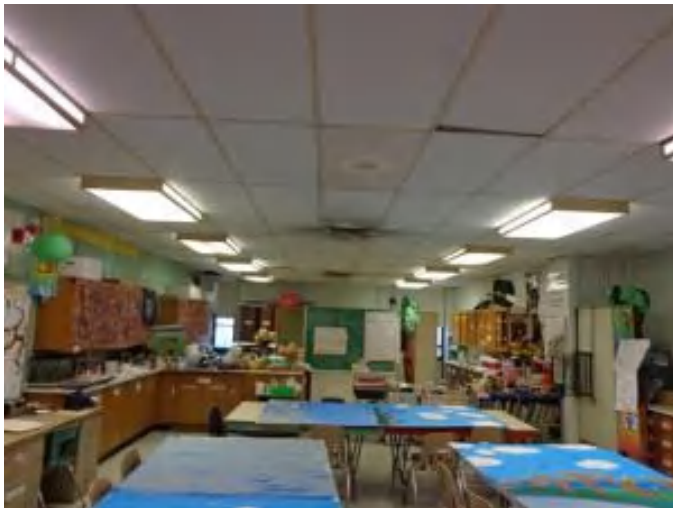
System: D5020 - Lighting and Branch Wiring

Lighting--Except for a few rooms, such as the Main Office, Principal's Office and Science Room 103, all of the fluorescent lighting fixtures have obsolete T12 lamps and are in fair to poor condition. Replacement of these fixtures is recommended in 3 to 4 years. Typically, 2x4 recessed fluorescent troffers with acrylic prismatic lenses are provided in ceilings with acoustical ceiling tile, including the cafeteria/auditorium, corridors, offices, faculty dining room, locker rooms, restrooms and Kindergarten K2. Classrooms and kitchen have surface mounted 2x4 modular fluorescent fixtures; stairwells have 1x4 fluorescent wraparound fixtures.

Location: Building wide
Distress: Beyond Service Life
Category: 3 - Operations / Maint.
Priority: 3 - Response Time (3-4 yrs)
Correction: Replace Lighting Fixtures (SF)
Qty: 55,767.00
Unit of Measure: S.F.
Estimate: \$1,006,212.60
Assessor Name: Ed Davis
Date Created: 01/24/2016

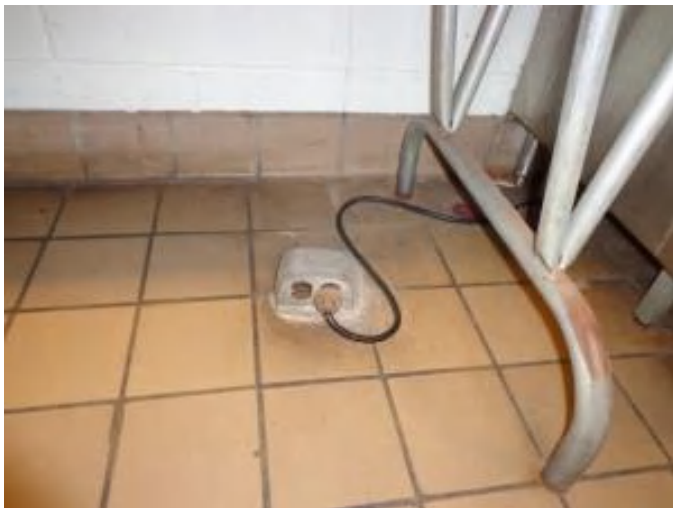
System: D5020 - Lighting and Branch Wiring

Receptacles-- Classrooms typically are not provided with an adequate number of receptacles. It is recommended that 4 to 6 additional duplex receptacles be provided in 26 classrooms using a metal surface raceway system. Because of the age of the wiring devices and branch circuit wiring, replacement of all receptacles in the building is included in this report (estimate of 150 duplex receptacles).

Location: Building wide
Distress: Failing
Category: 3 - Operations / Maint.
Priority: 3 - Response Time (3-4 yrs)
Correction: Replace Wiring Device
Qty: 150.00
Unit of Measure: Ea.
Estimate: \$75,416.61
Assessor Name: Ed Davis
Date Created: 01/24/2016

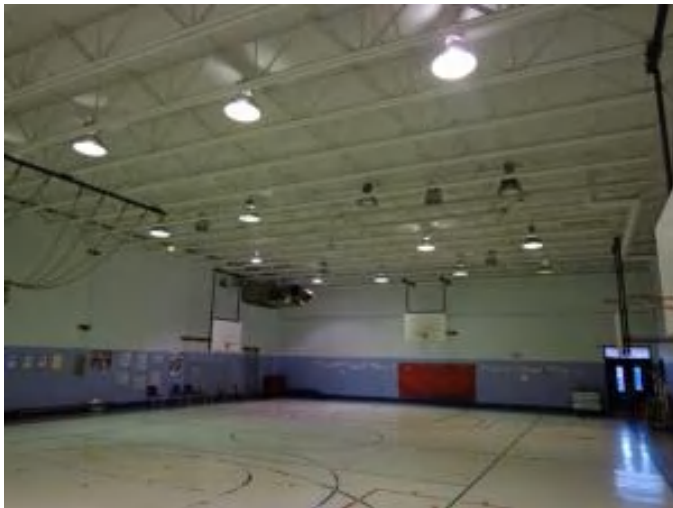
System: D5020 - Lighting and Branch Wiring

The gymnasium is illuminated with (20) metal halide industrial fixtures and six (6) incandescent industrial fixtures used for emergency lighting. The fixtures are in poor condition and have reached the end of their useful life. Replacement with LED fixtures is recommended for improved energy efficiency and reduced maintenance cost.

Location: Gymnasium
Distress: Beyond Service Life
Category: 3 - Operations / Maint.
Priority: 3 - Response Time (3-4 yrs)
Correction: Replace lighting fixtures
Qty: 20.00
Unit of Measure: Ea.
Estimate: \$69,287.16
Assessor Name: Ed Davis
Date Created: 01/24/2016

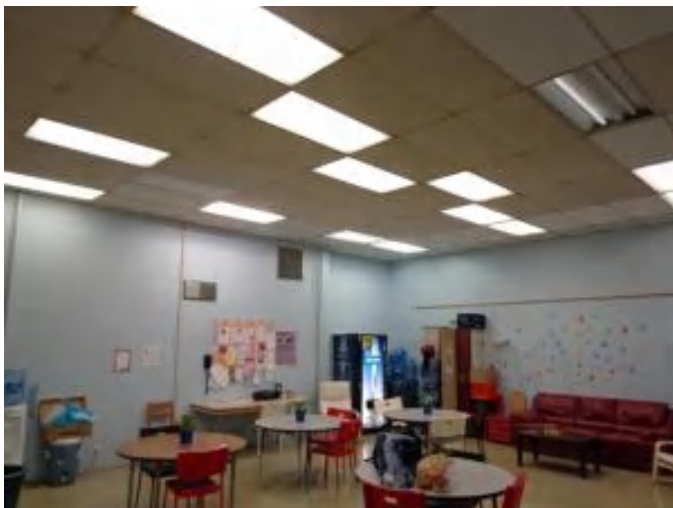
System: D5020 - Lighting and Branch Wiring

Location: Cafeteria/Auditorium
Distress: Beyond Service Life
Category: 3 - Operations / Maint.
Priority: 3 - Response Time (3-4 yrs)
Correction: Replace lighting fixtures
Qty: 40.00
Unit of Measure: Ea.
Estimate: \$30,253.47
Assessor Name: Ed Davis
Date Created: 01/24/2016

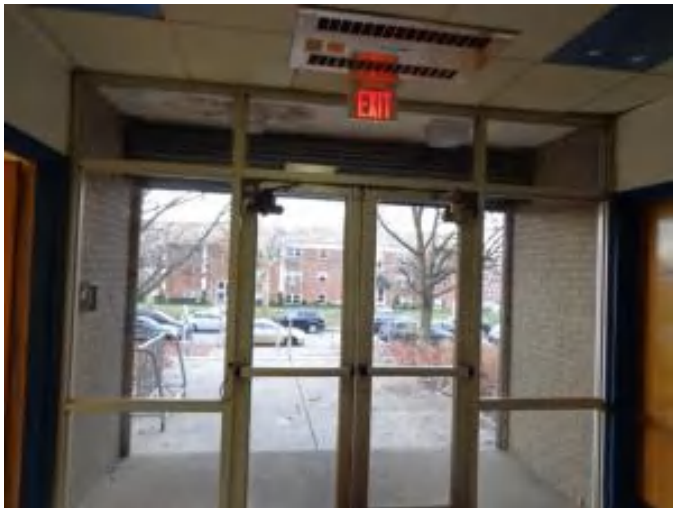
System: D5020 - Lighting and Branch Wiring

Location: Exit discharges
Distress: Beyond Service Life
Category: 3 - Operations / Maint.
Priority: 3 - Response Time (3-4 yrs)
Correction: Replace lighting fixtures
Qty: 6.00
Unit of Measure: Ea.
Estimate: \$8,665.68
Assessor Name: Ed Davis
Date Created: 01/24/2016

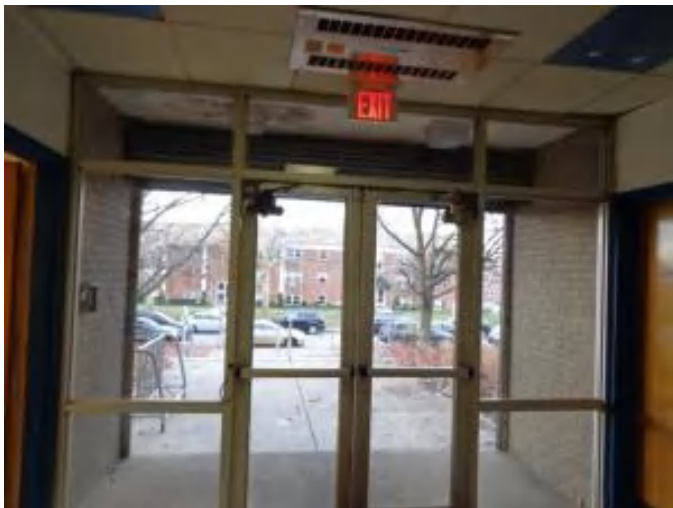
System: D5030 - Communications and Security

Location: Exterior doors
Distress: Inadequate
Category: 4 - Capital Improvement
Priority: 3 - Response Time (3-4 yrs)
Correction: Add/Replace Security System
Qty: 1.00
Unit of Measure: Ea.
Estimate: \$25,845.57
Assessor Name: Ed Davis
Date Created: 01/24/2016

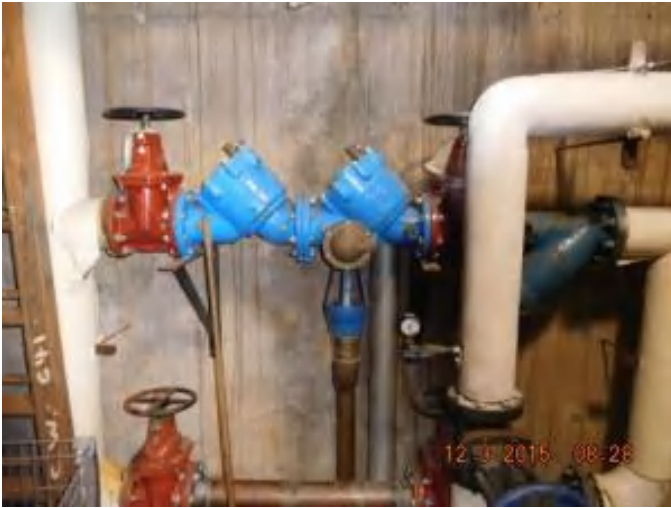
System: D2020 - Domestic Water Distribution

The plumbing piping systems are from original 1969 installation. The supply piping has exceeded the service life and should be replaced. The cast iron piping should be inspected for damage and replaced or repaired as required. The water heaters should remain serviceable up to fifteen years. The fixtures appear to have been replaced during the past ten years and should have remaining life of twenty five years.

Location: entire building
Distress: Beyond Service Life
Category: 3 - Operations / Maint.
Priority: 4 - Response Time (4-5 yrs)
Correction: Replace domestic water piping (75 KSF)
Qty: 73,100.00
Unit of Measure: S.F.
Estimate: \$370,424.35
Assessor Name: Ed Davis
Date Created: 02/19/2016

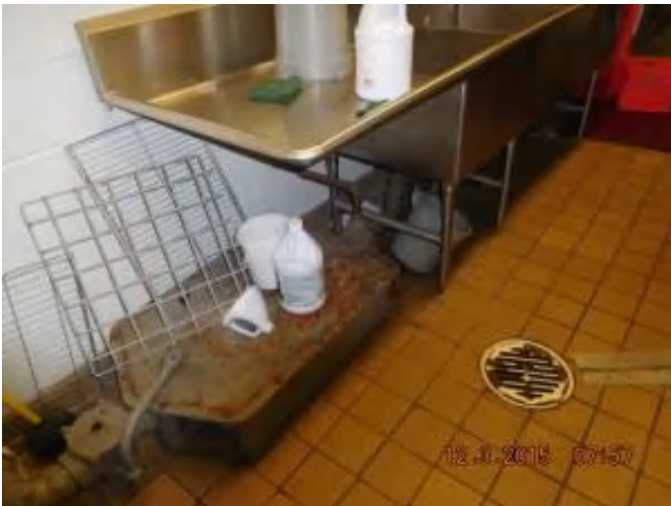
System: D2030 - Sanitary Waste

Location: entire building
Distress: Beyond Service Life
Category: 3 - Operations / Maint.
Priority: 4 - Response Time (4-5 yrs)
Correction: Inspect sanitary waste piping and replace damaged sections. (+50KSF)
Qty: 73,100.00
Unit of Measure: S.F.
Estimate: \$358,610.21
Assessor Name: Ed Davis
Date Created: 02/19/2016

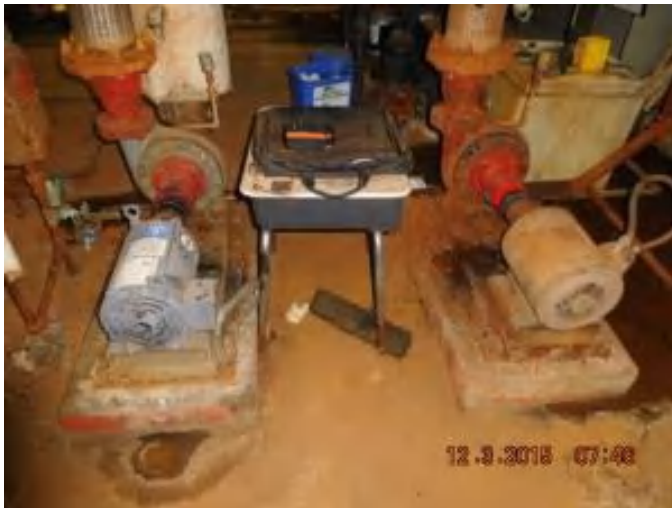
System: D3020 - Heat Generating Systems

Location: mechanical room
Distress: Beyond Service Life
Category: 3 - Operations / Maint.
Priority: 4 - Response Time (4-5 yrs)
Correction: Replace pump, base-mounted, end suction HHW (4" size, 7-1/2 HP, to 350 GPM)
Qty: 3.00
Unit of Measure: Ea.
Estimate: \$242,371.41
Assessor Name: Ed Davis
Date Created: 02/19/2016

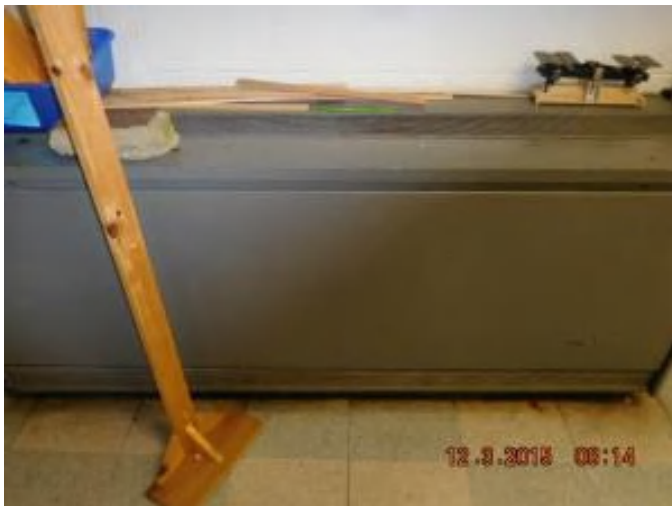
System: D3040 - Distribution Systems

Location: classrooms
Distress: Building / MEP Codes
Category: 2 - Code Compliance
Priority: 4 - Response Time (4-5 yrs)
Correction: Replace the existing unit ventilators with new units designed to provide adequate ventilation per ASHRAE Std 62 - insert the SF of bldg. in the qty.
Qty: 73,100.00
Unit of Measure: S.F.
Estimate: \$3,526,288.42
Assessor Name: Ed Davis
Date Created: 02/19/2016

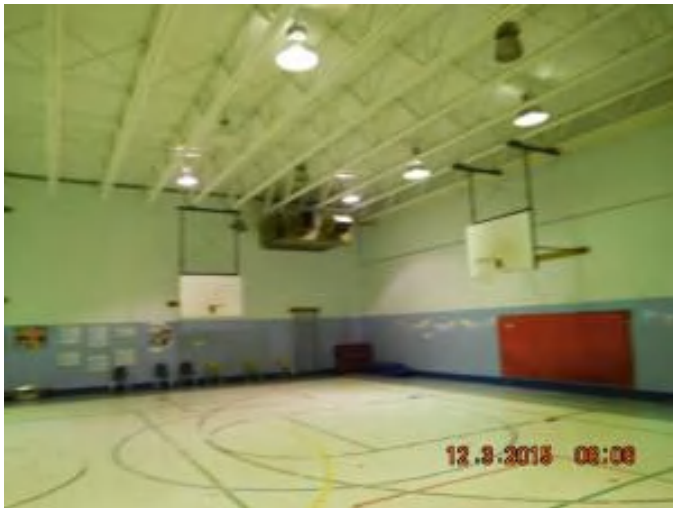
System: D3040 - Distribution Systems

Location: gymnasium
Distress: Building / MEP Codes
Category: 2 - Code Compliance
Priority: 4 - Response Time (4-5 yrs)
Correction: Replace HVAC unit for Gymnasium (single station)
Qty: 5,000.00
Unit of Measure: S.F.
Estimate: \$189,559.18
Assessor Name: Ed Davis
Date Created: 02/19/2016

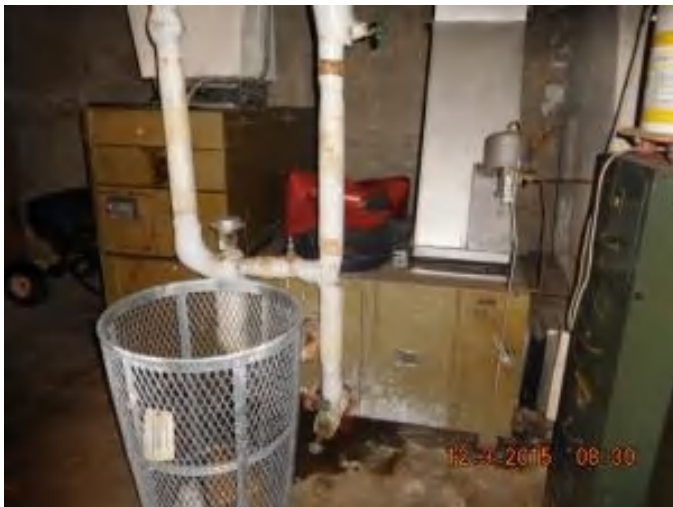
System: D3040 - Distribution Systems

Location: nurses area
Distress: Building / MEP Codes
Category: 2 - Code Compliance
Priority: 4 - Response Time (4-5 yrs)
Correction: Replace indoor AHU, CV, DT (15T)
Qty: 10.00
Unit of Measure: TonAC
Estimate: \$187,403.32
Assessor Name: Ed Davis
Date Created: 02/19/2016

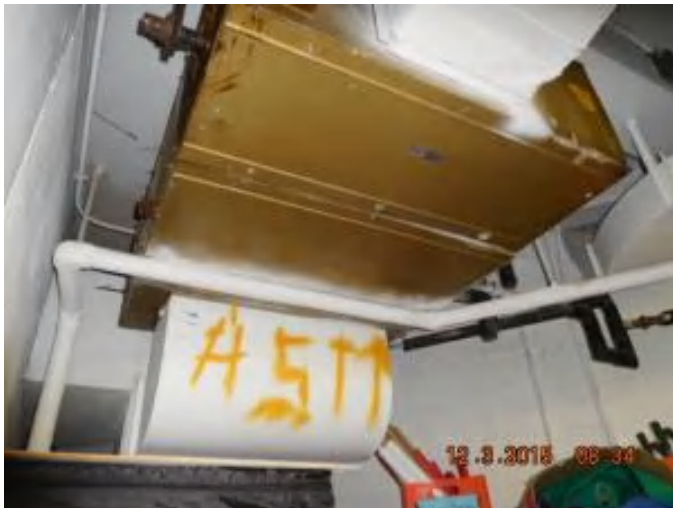
System: D3040 - Distribution Systems

Location: art area
Distress: Building / MEP Codes
Category: 2 - Code Compliance
Priority: 4 - Response Time (4-5 yrs)
Correction: Replace indoor AHU, CV, DT (15T)
Qty: 10.00
Unit of Measure: TonAC
Estimate: \$187,403.32
Assessor Name: Ed Davis
Date Created: 02/19/2016

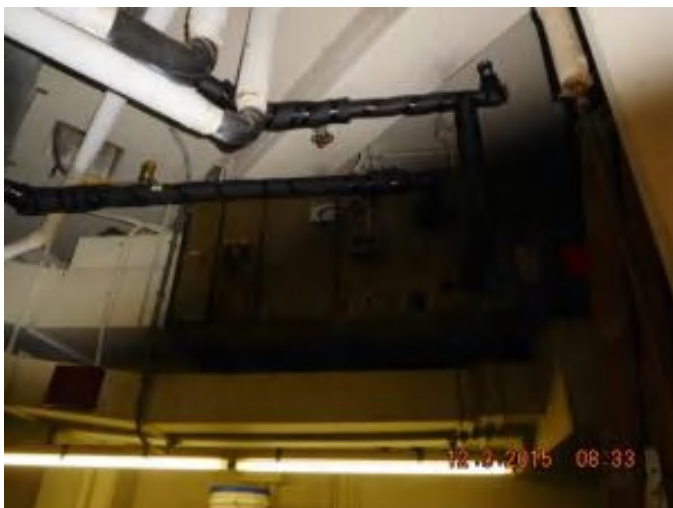
System: D3040 - Distribution Systems

Location: music area
Distress: Building / MEP Codes
Category: 2 - Code Compliance
Priority: 4 - Response Time (4-5 yrs)
Correction: Replace indoor AHU, CV, DT (15T)
Qty: 10.00
Unit of Measure: TonAC
Estimate: \$187,403.32
Assessor Name: Ed Davis
Date Created: 02/19/2016

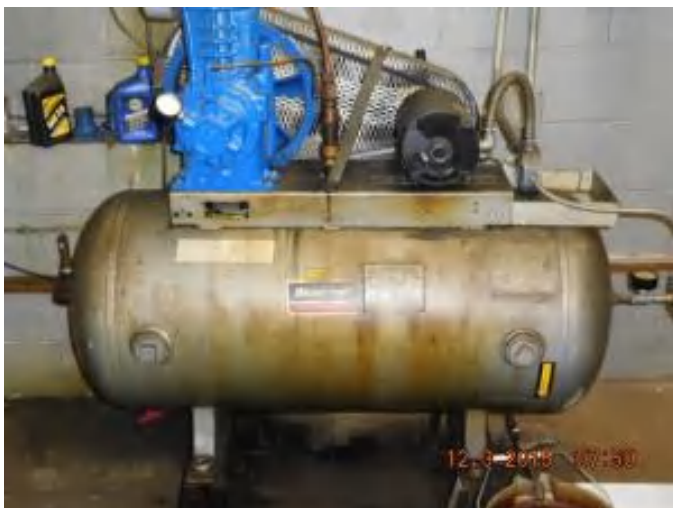
System: D3060 - Controls & Instrumentation

Location: entire building
Distress: Inadequate
Category: 4 - Capital Improvement
Priority: 4 - Response Time (4-5 yrs)
Correction: Replace pneumatic controls with DDC (75KSF)
Qty: 73,100.00
Unit of Measure: S.F.
Estimate: \$1,568,150.38
Assessor Name: Ed Davis
Date Created: 02/19/2016

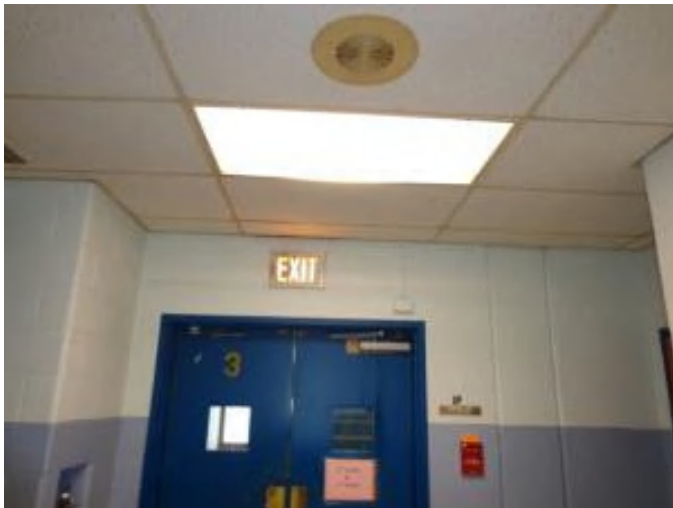
System: D5030 - Communications and Security

Location: Corridors
Distress: Appearance
Category: 3 - Operations / Maint.
Priority: 4 - Response Time (4-5 yrs)
Correction: Add/Replace Paging System
Qty: 20.00
Unit of Measure: Ea.
Estimate: \$12,855.75
Assessor Name: Ed Davis
Date Created: 01/24/2016

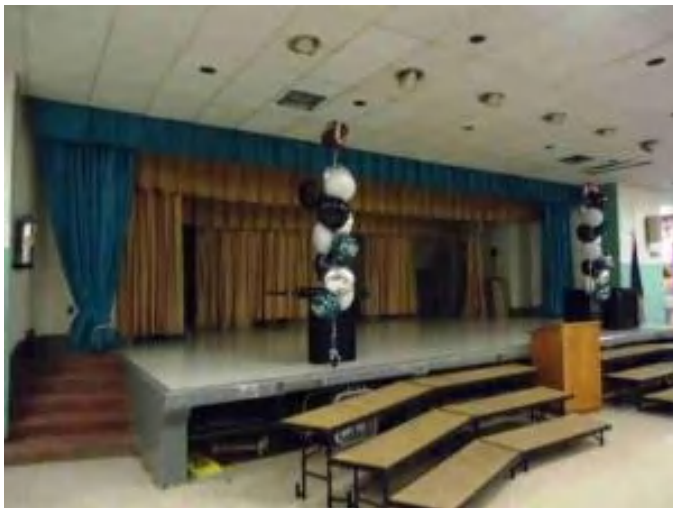
System: E2010 - Fixed Furnishings

The school stage has a stage curtain assembly that appears to be from the original construction. Modern applications are typically fire-proof applications with adjustable tracks and electric support for operation. The curtains are torn in a few section and the track is not functioning properly, overall the system is in poor condition. It is recommended that the curtain and track system be upgraded to a new system. Special care should be considered in regards to modern fire proofing for the new installation.

Location: Stage
Distress: Damaged
Category: 3 - Operations / Maint.
Priority: 4 - Response Time (4-5 yrs)
Correction: Remove and replace stage curtain - insert the LF of track and SF of curtain
Qty: 1.00
Unit of Measure: Ea.
Estimate: \$13,831.55
Assessor Name: Ed Davis
Date Created: 02/16/2016

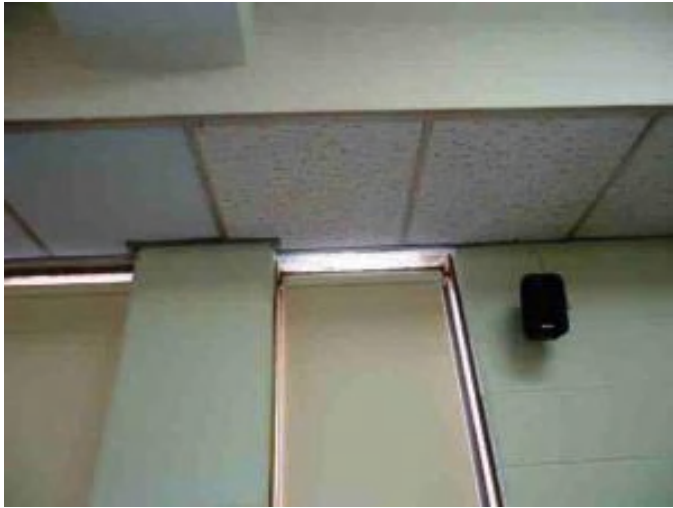
System: C3030 - Ceiling Finishes

The ceiling finish is a mix of painted and 2 x 4 Acoustical tile finish. Ceilings have been repaired in several areas and is in good condition considering the age of the application and the current condition of the school. The ceiling finish is expected to require upgrades to support the recommended mechanical electrical efforts in this report. This deficiency provides a budgetary consideration for removal and replacement of the current ceiling finish to a new acoustical tile finish. Considering the recommended mechanical and electrical upgrades this effort should be completed as part of an overall renewal program for the school. No work should be considered until after the recommended exterior efforts are complete.

Location: Building wide
Distress: Damaged
Category: 3 - Operations / Maint.
Priority: 5 - Response Time (> 5 yrs)
Correction: Remove and replace suspended acoustic ceilings - lighting not included
Qty: 50,000.00
Unit of Measure: S.F.
Estimate: \$754,121.51
Assessor Name: Ed Davis
Date Created: 02/16/2016

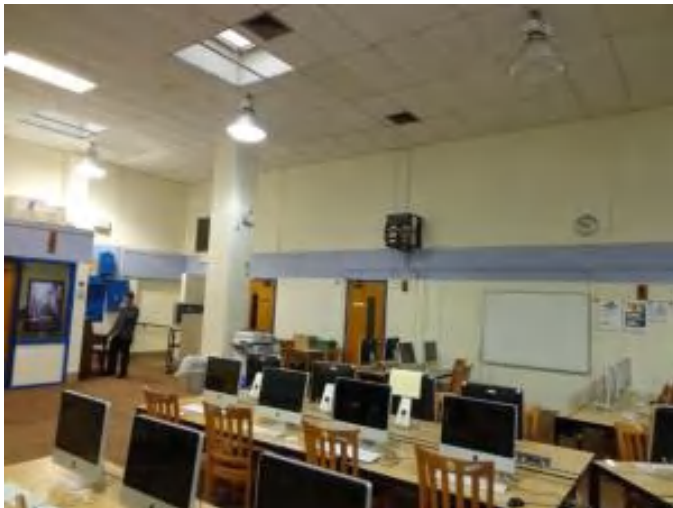
System: D5020 - Lighting and Branch Wiring

The IMC has 15 surface metal halide industrial fixtures mounted to acoustical tile ceiling and 2x4 fluorescent troffers to serve as emergency lighting. Replacement with recessed LED fixtures is recommended for aesthetics, improved energy efficiency and reduced maintenance cost.

Location: IMC
Distress: Beyond Service Life
Category: 3 - Operations / Maint.
Priority: 5 - Response Time (> 5 yrs)
Correction: Replace lighting fixtures
Qty: 15.00
Unit of Measure: Ea.
Estimate: \$49,895.96
Assessor Name: Ed Davis
Date Created: 01/24/2016
