# Hamilton Disston Elementary School

## Major Renovation & Addition Scope of Work

Rev. July 24, 2020

School District of Philadelphia  
Office of Capital Programs  
440 North Broad Street  
Philadelphia, PA 19130

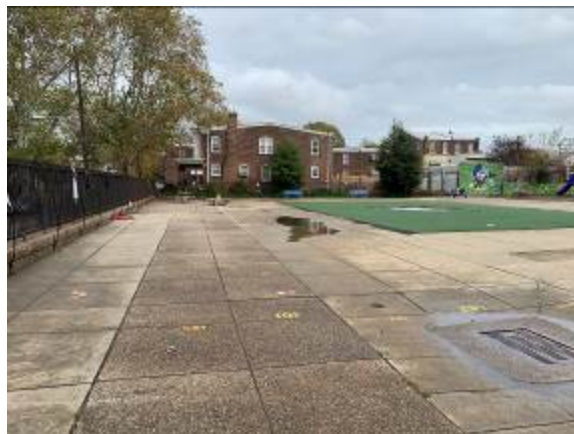
Condition: The site has storm drain surface inlets within the concrete play surface. At least one of the inlets had ponding condition at the time of survey. These inlets connect to the sewer that is a combined storm/ sanitary sewer in this region of the City.

Concrete play surface

Recommendation: All inlets scheduled to remain should be cleaned out as part of this project. Inlets must be protected from sediment and debris during construction.

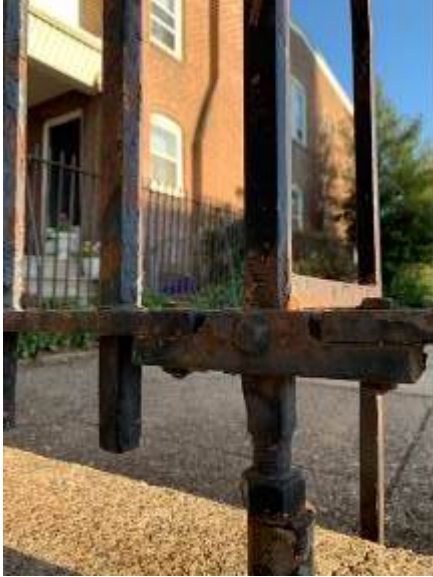
Condition: Retaining walls border the property on three sides at varying heights. A few of the masonry piers at the corners of the fence line are cracked. The wall retains the residential neighboring property in the NE corner of the site and shows some deflection. Most of the sidewalk side of the brick retaining walls have been recently painted and appear in good condition. At the top of the retaining walls is an existing iron fence that has surface deterioration and corrosion along the entire run. The fencing bordering the residential properties is low and does not provide good security for the site. The fence continues at grade around the side of the building fronting Knorr St.

Iron fencing

Recommendation: The short run of retaining wall noted as deflecting should be reviewed and repaired. Fencing that immediately borders residential properties should be replaced with a higher, safer fence type. The remaining iron fence shall be restored and refinished.

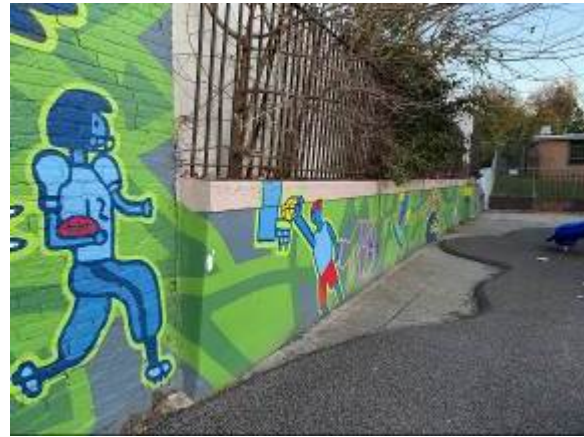
Residential side retaining wall

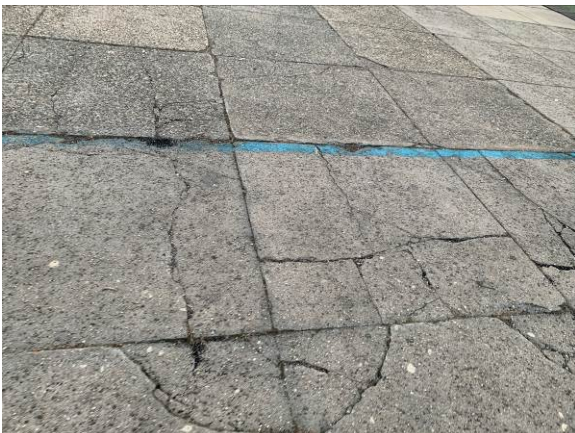
Condition: The existing play area surface and building yard of approximately 32,566 square feet is made up of concrete squares, some of which have completely cracked and pose a tripping hazard. It appears that individual replacements of damaged squares has taken place over time. Currently there is not a separation between the yard area that has access to manholes, the access drive, and the designated play area. The rear yard area is also where early grade children line up to enter the building every morning. The current facilities maintenance Work Request Report lists open maintenance items of surface damage and tripping hazards across the existing surface.

Concrete surface

Recommendation: Replace sections of concrete that are beyond repair. A renovated yard and play area should be planned to incorporate a building addition and provide separation of a lineup/ play area from all building infrastructure access and trash and waste storage. The new design should consider how surface areas can better meet the sidewalk grade and eliminate or minimize the need for stairs and ramps.

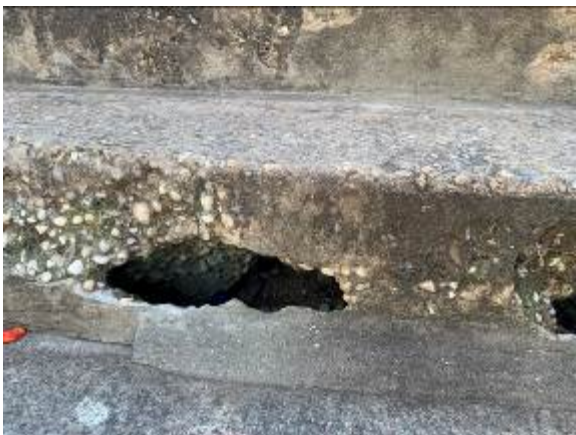
Condition: There are concrete stairways to enter the yard, and the building at all sides. The stairways providing primary site access along Cottage Street are failing at some locations: stair treads are pulling away from the risers, or are sloping and cause for concern. The existing pipe handrails are in fair condition, and at a minimum should be refinished. The existing sidewalks show period replacement of different areas with varying current conditions. There are missing and decaying street trees at some locations. The sidewalk along the primary entry path, down Cottage Street, shows damage and wear at joints and through sections.

Concrete Stair Riser

Recommendation: The damaged stairways should be replaced with new concrete stairs where needed by the new overall site design. Accessibility and safety should be considered in how to transition from the sidewalk elevation to that of the building or yard. Handrails that do not meet all local building code requirements should be replaced.

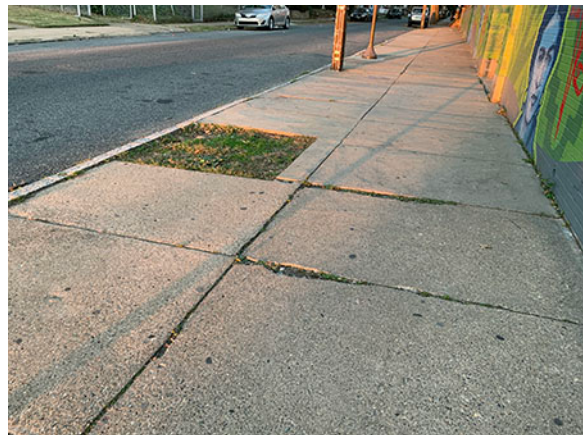
Sidewalk Along Cottage St.

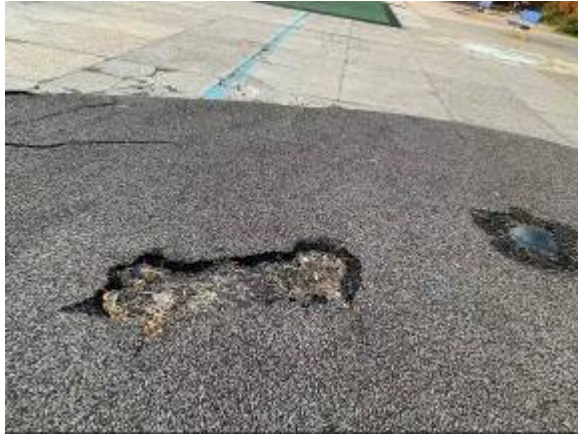
Condition: There is existing play equipment that is relatively new and in good condition. However the safety surface has significant holes. There are new metal benches and a few aged, damaged, concrete tables. The entire play area is open to community access and use at all times.

**Failing Safety Surface**

Recommendation: Play area surface should be replaced, and the equipment re-installed at completion. The bench locations should be reconsidered as part of the building

alteration and addition planning. The building currently makes the play area available to the public, and that condition is expected to be maintained.

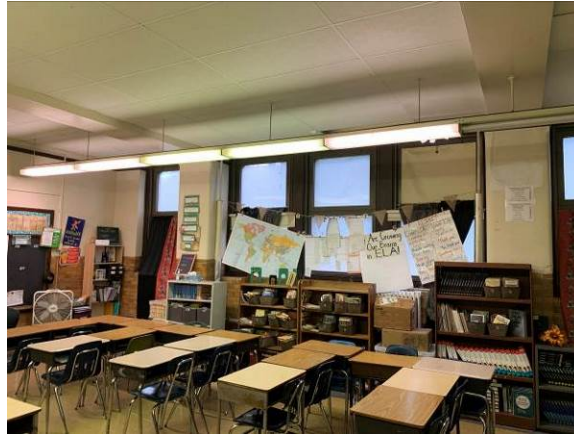
Condition: Some rooms have pull- down shades that are torn, or do not function. Most windows do not have treatments and staff provided curtains and coverings have been attached.

**Typical Classroom Windows**

Recommendation: Provide new roller shades at all windows.

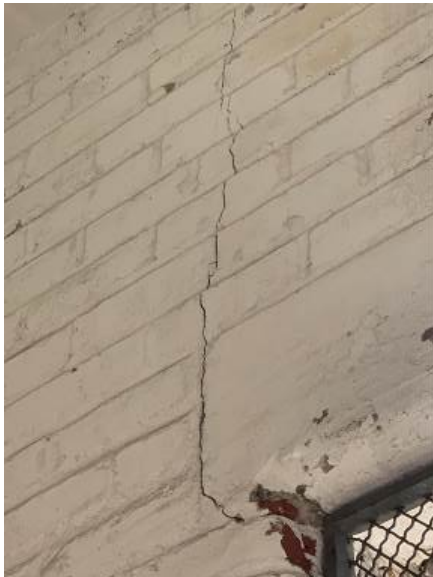
Condition: Interior storefronts at the primary stairwells have wire glazing and hardware that does not appear to meet current building code. Existing stairways are concrete with steel treads. There is some cracking in the concrete and some treads have come loose. Concrete floors at intermittent landings or near doorways are surface worn. There are

wooden handrails that have open metal infill without guards. Rails on the outside wall are pipe. There are two open egress stair towers built to the courtyard side of the building that lead to grade. They are constructed of masonry and concrete. There is some cracking of the brick and some exposed steel in the concrete. All surfaces are painted but worn. Window openings are supported by concrete lintels that are in poor condition and show signs of movement.

**Cracking in Exterior Stairwell**

**Recommendation:** Storefront doorways that do not meet current egress code should be replaced. Concrete cracking should be reviewed and repaired. Steel treads should be reattached or replaced where necessary. Concrete floors at interior stairways require surface restoration. All handrails should be replaced with code compliant railing and guards. The open egress stair towers should be reviewed for code compliance and enclosed if determined to be required. Locations of exposed steel should be treated and sealed. Any dislodged lintels should be reset into their correct position and repointed.

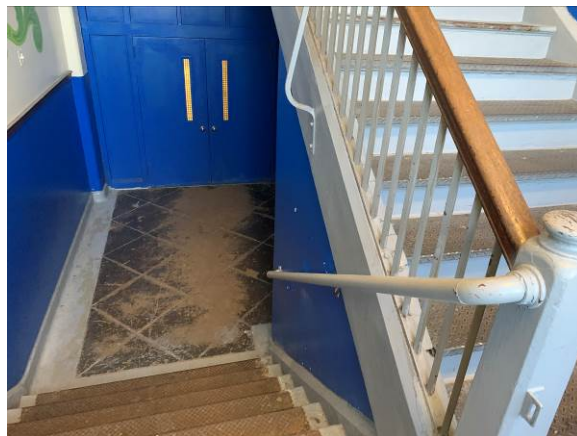
**Primary Stairway**

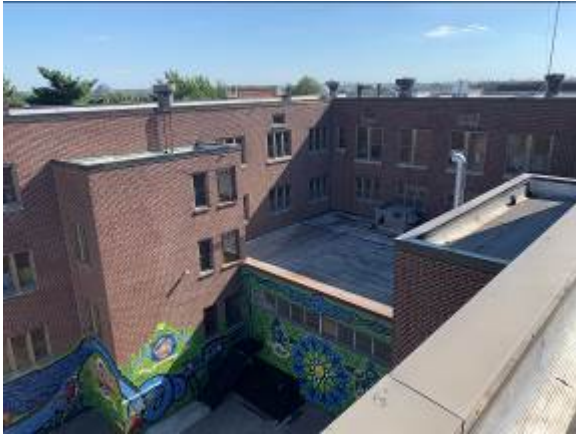
Condition: The existing roof construction over the main building is a built-up, low slope roof of rolled asphalt with ceramic impregnated granules on a reinforced concrete deck. The roof is broken into five different levels: a primary 3<sup>rd</sup> floor roof; two exterior stair tower roofs; a low roof over an extended 1<sup>st</sup> floor area, and a partial extended 2<sup>nd</sup> floor area. The larger areas do *not* positively pitch to the existing roof drains due to the compacted and failing insulation material, though no leaks are in the current maintenance records. There are overflow pipes that sit approximately 8" above the roof surface and drain to the exterior side of the building onto the ground or adjacent roofs below. There is new metal capping, and flashing along the perimeter parapet. On the main roof there are a number of curbs that are no longer in use and have been capped and flashed over. There is an access penthouse with some step cracking in the masonry evident. There are also exhaust fans, bathroom vents, a small antenna, and a flag pole on the main roof.

**Multi- Level Roofing**

Recommendation: There should be a complete replacement of roofing material. All limestone coping should be repointed and repaired. Repoint and make repairs to the existing parapet. New energy code compliant insulation and 2 ply modified bitumen roof assembly should be installed. Refinish all ferrous material on the roof, this includes vents, ladders, etc.

The penthouse stair tower requires re-pointing and replacement of the exterior door and steel lintel. Provide OSHA compliant exterior stair access to roof. Roof drains shall be replaced to interior connecting point. They shall also be scoped and cleared or repaired as determined.

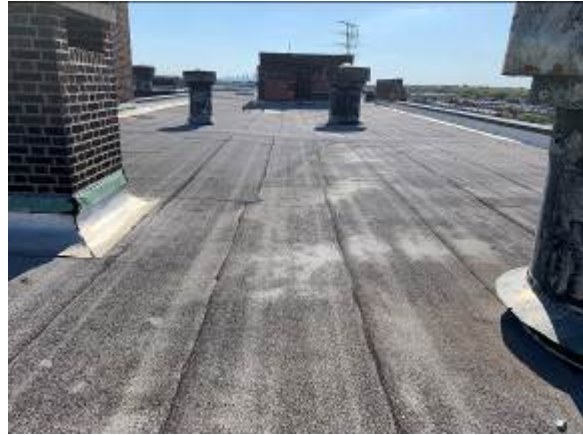
**Typical Roof Condition**

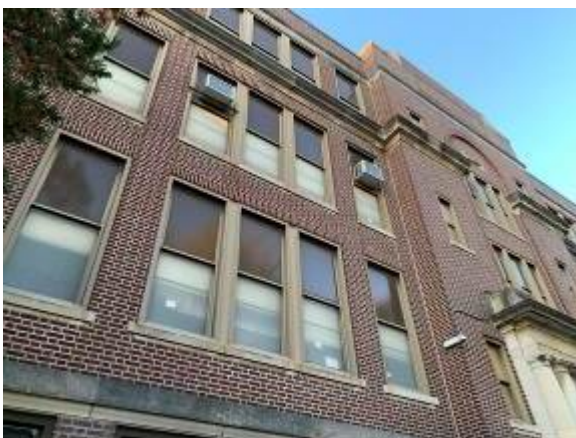
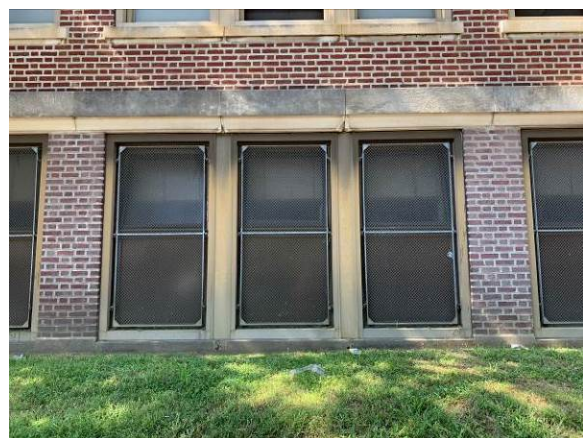
Condition: The existing windows are not original to the building but show failures and problems with the glazing. They are recorded as being replaced in the early 1990's. They are single pane, contain plexi-glass and are not energy efficient. There are windows at all three levels, as well as full height at the basement. There are some windows within the existing auditorium that contain stained glass infills.

**Northwest Upper Façade**

**Northwest Windows at Grade**

Recommendation: All windows should be replaced with new, thermally broken metal units with low E double pane glazing. New units should have appropriate daylight control to take advantage of passive solar heating and maximizing electrical lighting efficiency. New units will require integrated security grills for grade level, and tilt-in operable sections at some percentage of all the openings in compliance with all applicable codes. The window replacement work will include repair to the existing openings, and cleaning of the concrete sills. Exposed lintels should be cleaned and painted with a corrosion inhibiting finish.

No historical restoration work is anticipated to be required. Stained glass windows should be evaluated and repaired/ resealed as necessary. The building's AHERA report notes the existing window sealant as "assumed" to be positive for asbestos and should be expected to be part of the Environmental remediation scope.

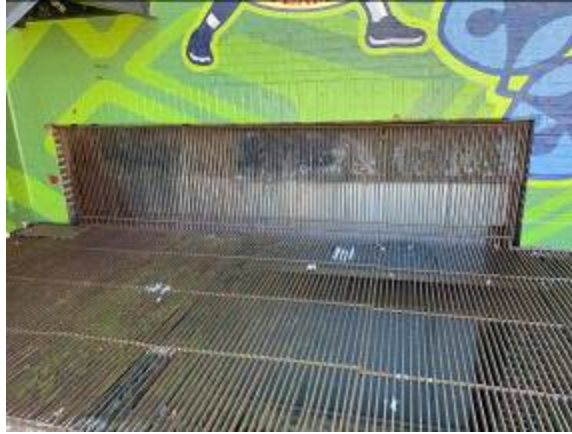
**Rear Ventilation Opening and Lintel**

**Recommendation:** Repoint and make localized repairs on the building as needed to maintain a weather tight, structurally sound exterior. Limestone at the roof line should be exposed and repointed during re-roofing activities. The Limestone banding on the building exterior should be cleaned and all joints should be properly grouted. The large rear lintel should be repaired/ replaced.

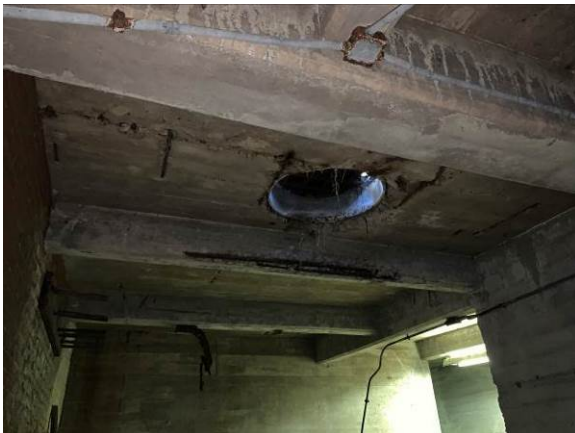
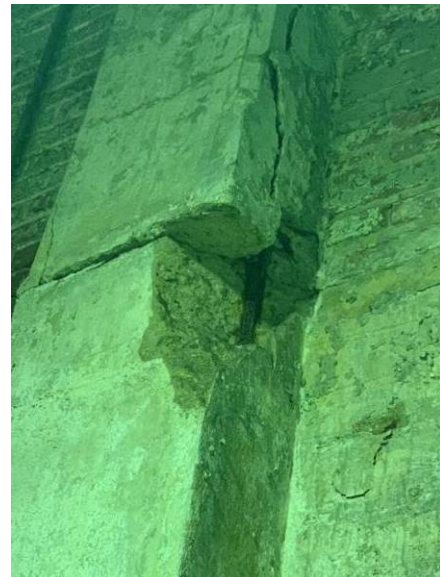
**Fuel Storage Room**

**Mechanical Room**

**Recommendation:** The damaged column in the mechanical room should be stabilized, further evaluated for underlying causes, and repaired. Beams under the fuel storage area should be repaired.

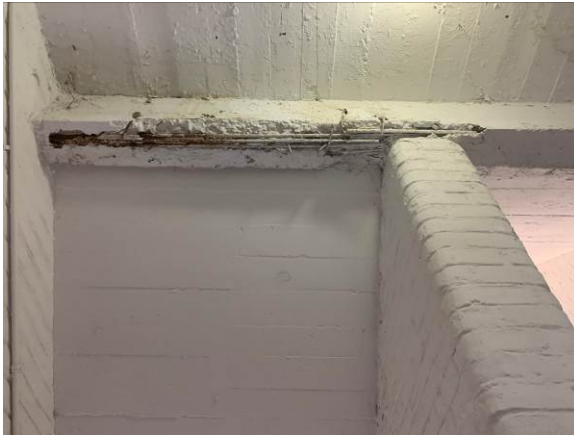
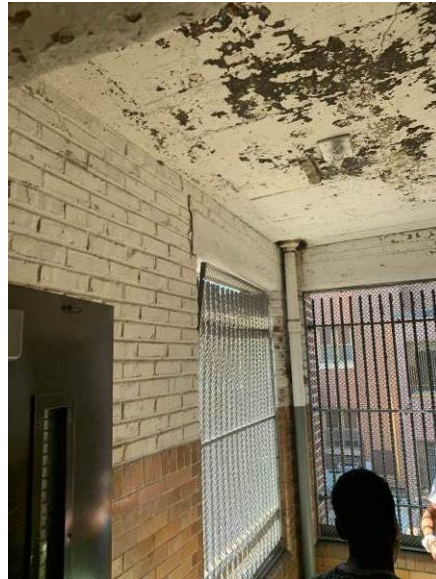
Exterior Egress Stairway

Recommendation: Repairs are necessary in the stair towers. Exposed steel should be treated, and the slabs should be reconstructed to meet the appropriate bearing requirements.

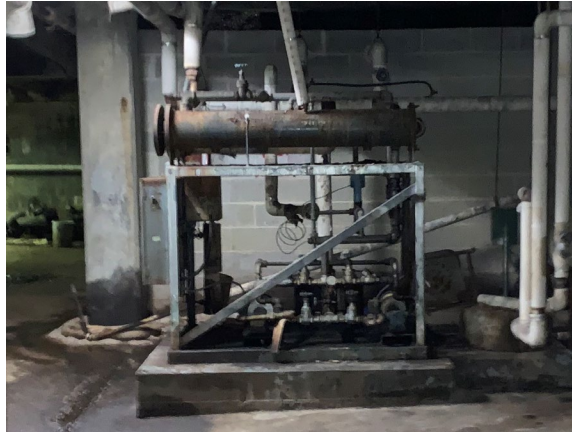
**Fuel Delivery System**

Recommendation: Remove the two, 10,000 gallon underground storage tank (UST) located underground beneath the paved schoolyard and associated delivery system and infrastructure. Confirm gas service can handle additional heating capacity required for new addition and kitchen. If not request utility service upgrade as required.

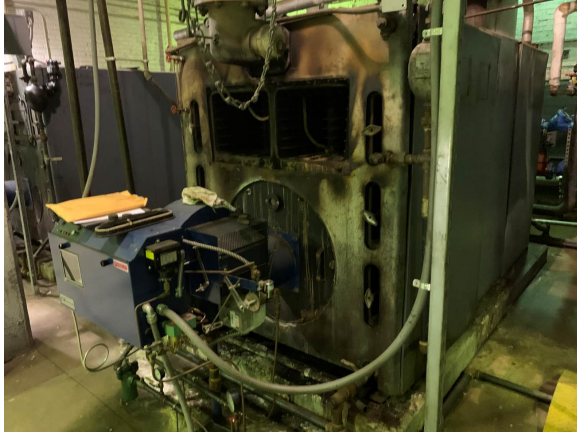
**Steam Boiler**

Recommendation: Remove the two 4,061 MBH Weil McLain 94 series steam boilers estimated to have been in service since the 1970s. Remove existing steam boilers and steam distribution system. Install natural gas powered, high efficiency, condensing hot water boilers sized for existing and new building.

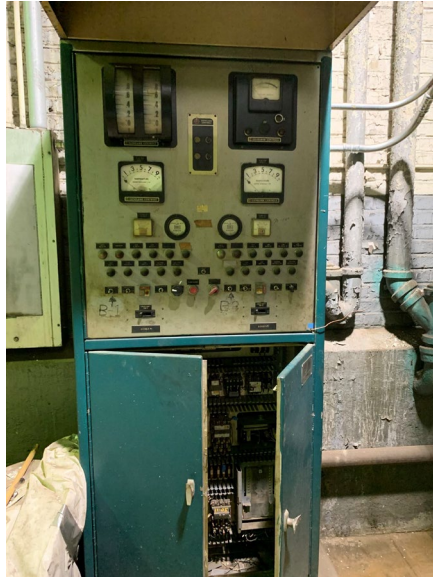
**HVAC Controls**

Recommendation: The original control valves, dampers and pneumatic actuators are over 65 years old and should be replaced. Replace the pneumatic controls for the HVAC systems with modern DDC modules, valves and actuators to improve reliability and energy efficiency. New packaged equipment such as unit vents, chiller, boilers, and chiller shall have factory installed integral controllers. Stand- alone equipment such as pumps, fans, and dampers shall require new programmable controllers. The chilled water/hot water system shall be manually changed over. Provide a new building automation system (BAS) with communication interface to the preferred BACnet system in use throughout the District.
