**PAINT AND PLASTER STABILIZATION
JAMES DOBSON ELEMENTARY SCHOOL**

4667 Umbria Street
Philadelphia, Pennsylvania 19127

**THE SCHOOL DISTRICT OF PHILADELPHIA
OFFICE OF ENVIRONMENTAL MANAGEMENT**

April 5th, 2019

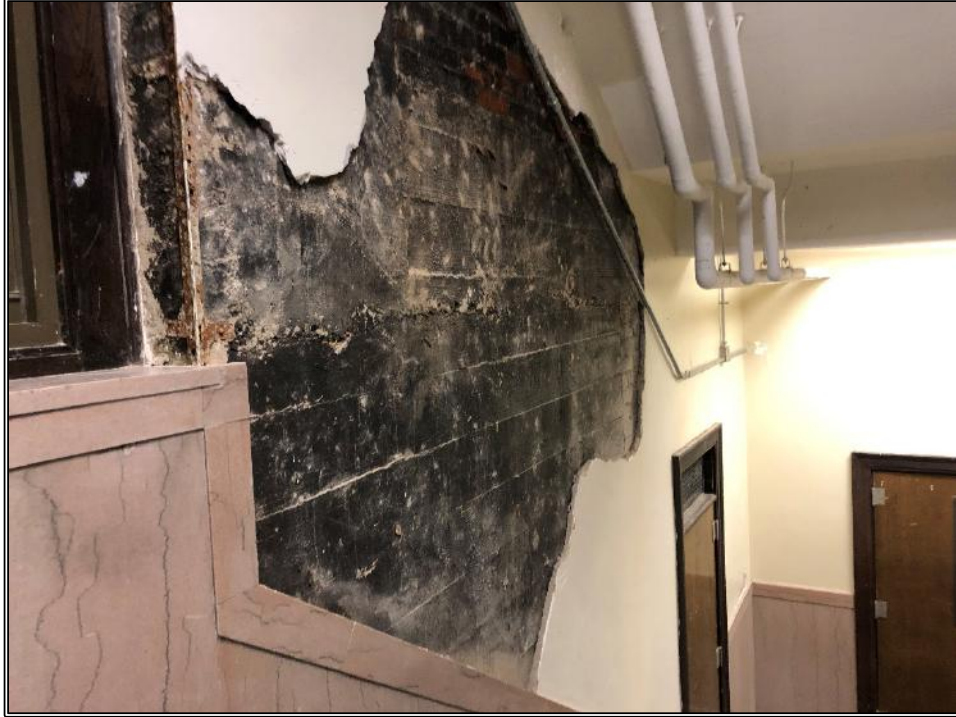
Photo 1: Damaged Plaster Wall

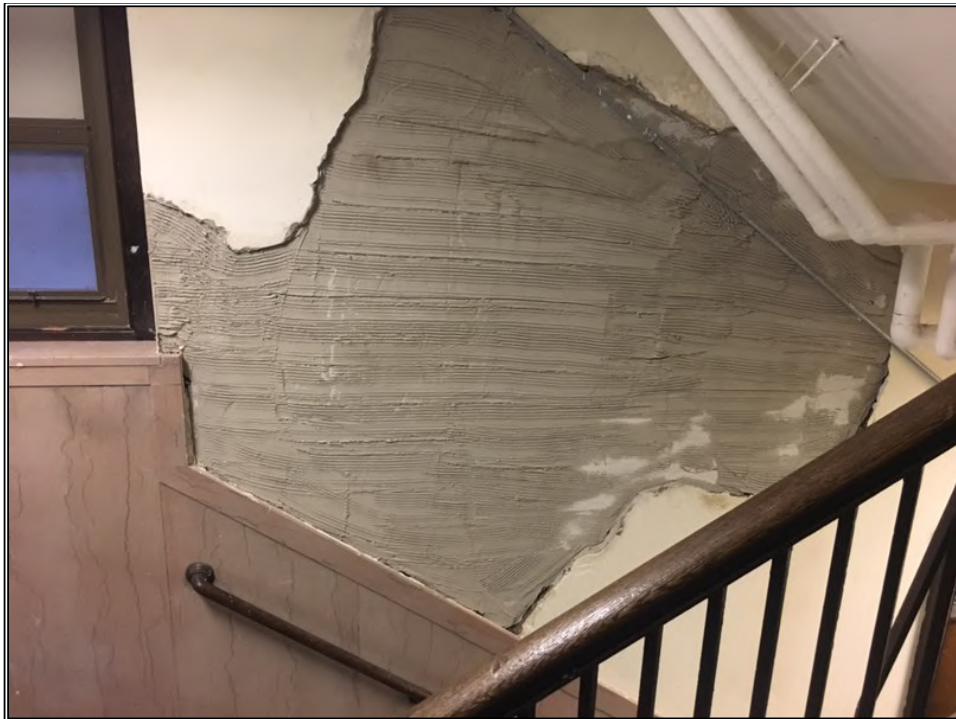
Photo 2: Plaster Repair on Damaged Wall

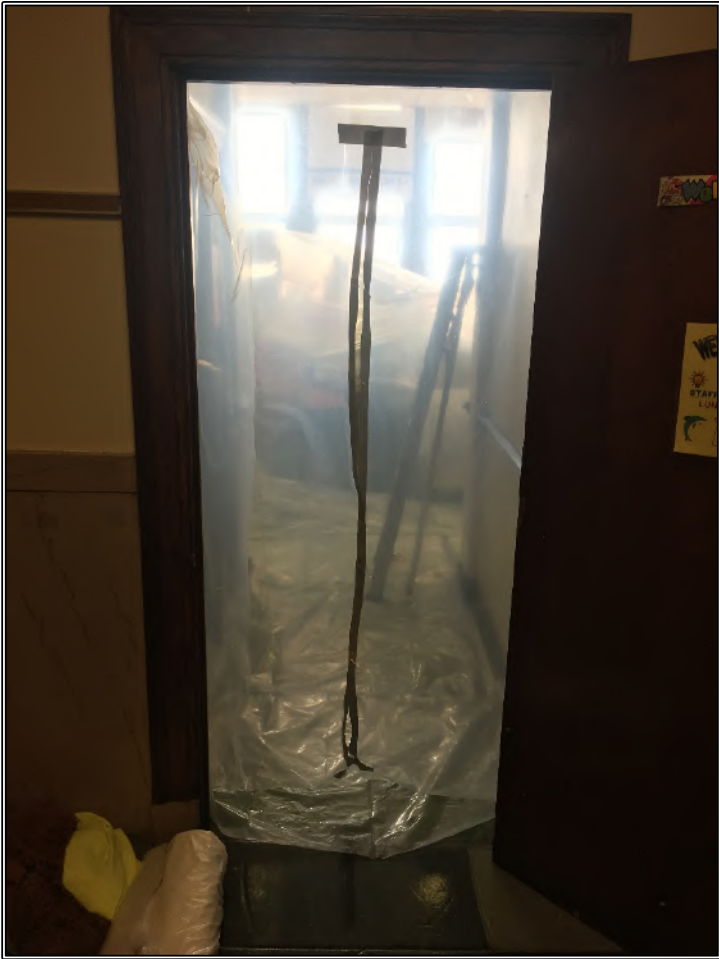
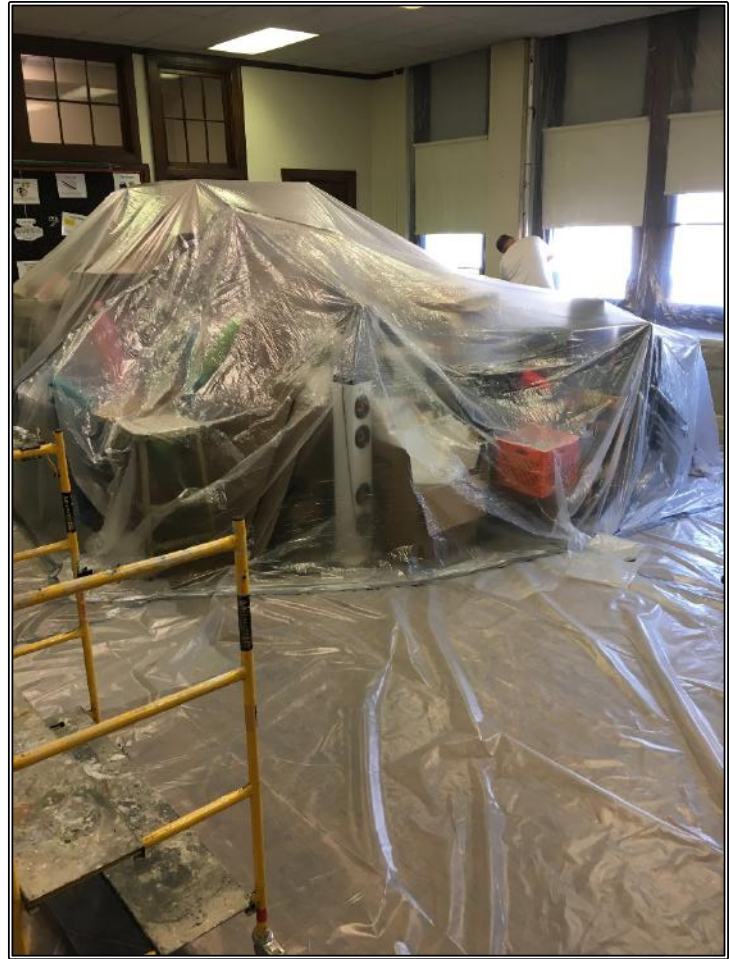
Photos 3 & 4
Engineering Controls being Prepared

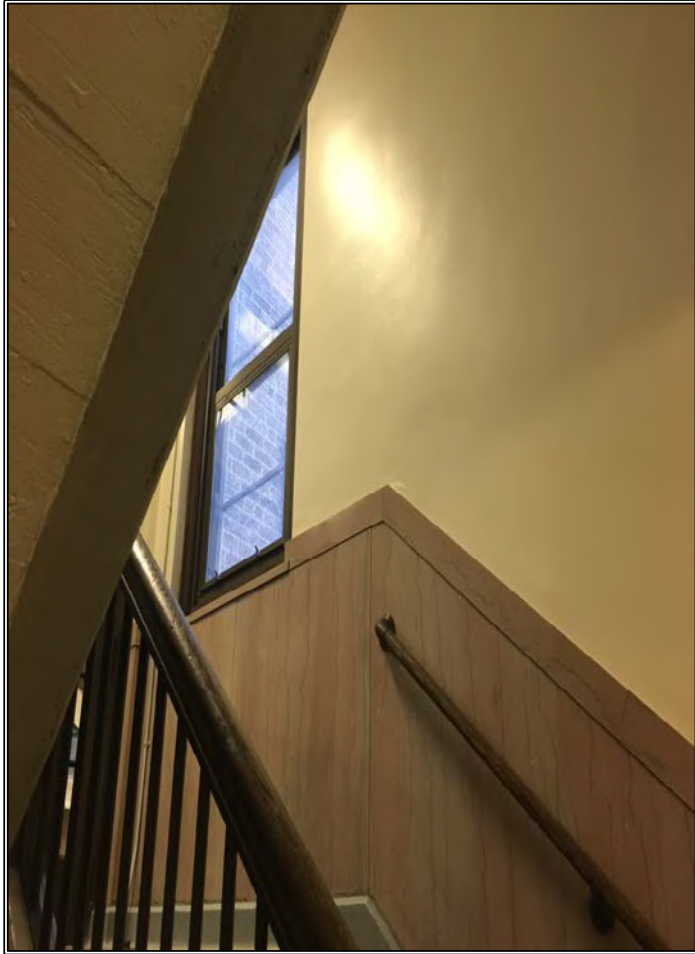
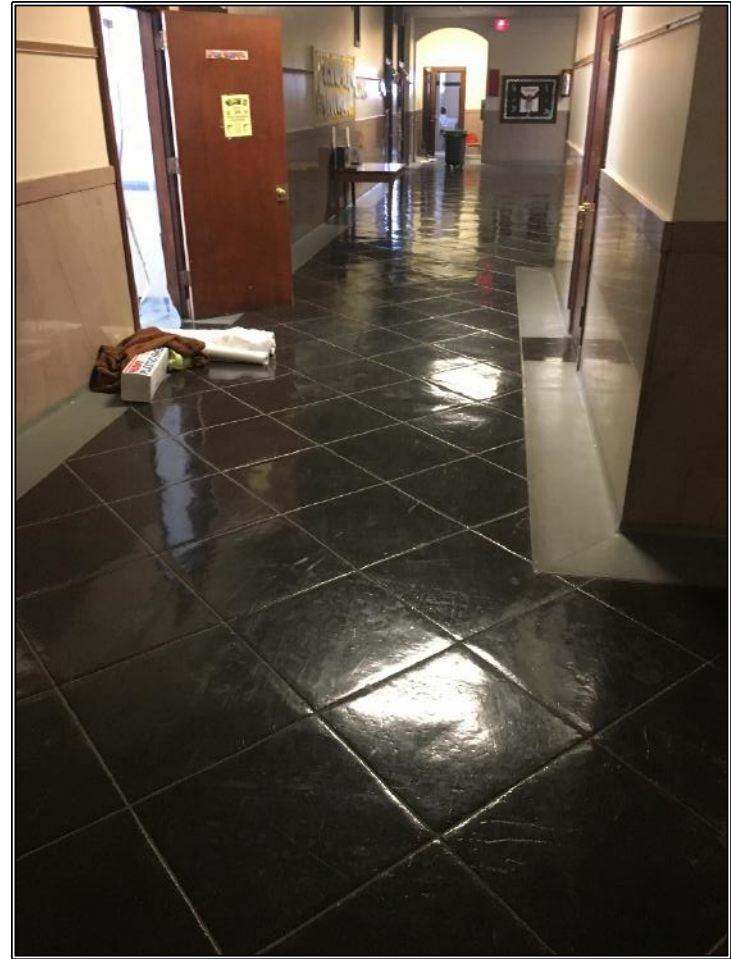
Photos 5 & 6
Stairwell and Hallway after Stabilization
