Facility Condition Assessment Summary Report

Cook-Wissahickon School

School District of Philadelphia
S641001;Cook-Wissahickon
Final
Site Assessment Report
January 31, 2017

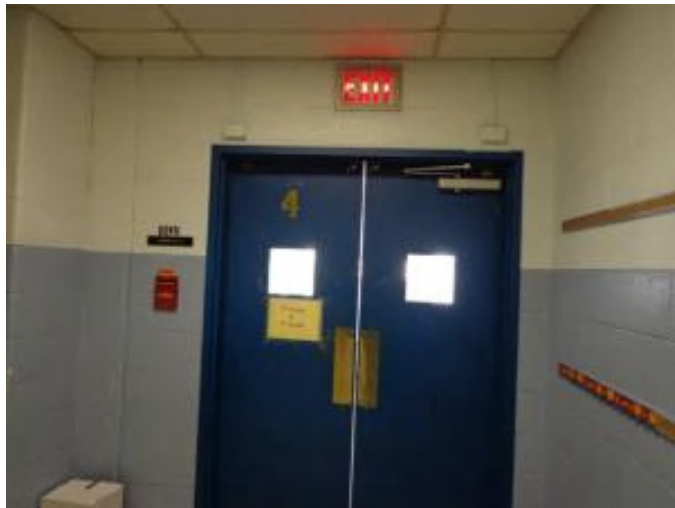
Location: Building wide

System: D5030 - Communications and Security

Distress: Life Safety / NFPA / PFD

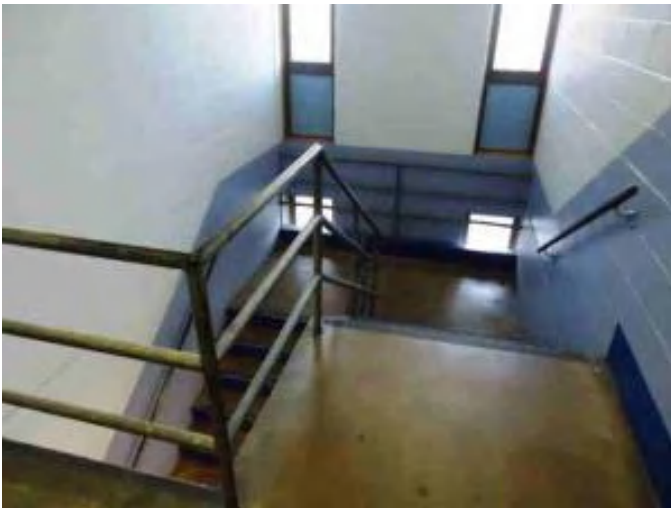
Location: Stairs

Current requirements for stairs indicate that they have graspable handrails on both sides, that the rails have a specific end geometry, and that the handrails continue horizontally at the landings. In addition, guardrails must prevent the passage of a 4 inch diameter sphere (6 inches in the triangle formed by the lower rail and tread/riser angle). Although the stairs are compliant with the code enforced at the time of construction until a major renovation occurs, they are deficient in handrail and guardrail design relative to current standards. Future efforts should include comprehensive stair railing removal and replacement upgrades.

System: C2010 - Stair Construction

Distress: Life Safety / NFPA / PFD

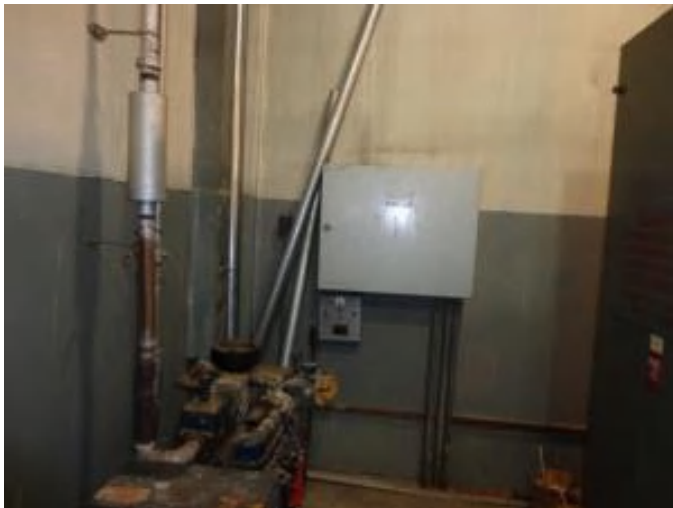
Location: Mechanical Room 019

System: D5090 - Other Electrical Systems

Distress: Beyond Service Life

Notes: Replace 15 kW standby generator and automatic transfer switch (ATS). Increase generator size to 30 kW to allow capacity for additional loads and future capacity.

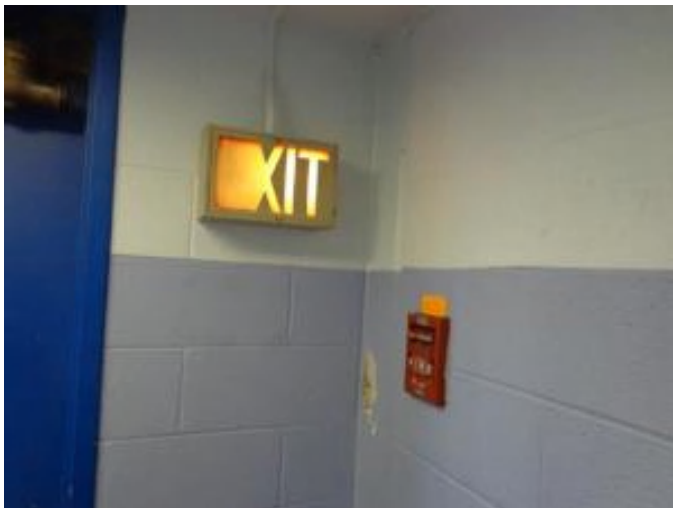
Location: Building wide

System: D5090 - Other Electrical Systems

Distress: Beyond Service Life

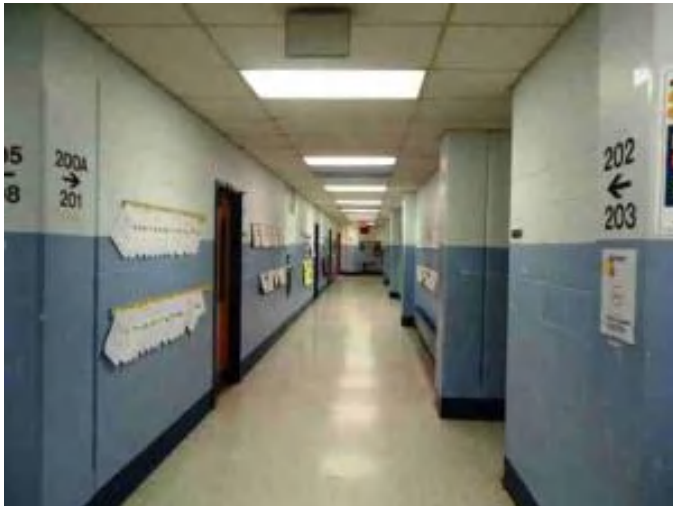
Location: Building Wide

System: C1030 - Fittings

Distress: Damaged

Notes: There is no directional signage and room signage is a custom design in places and scarce or painted with no consistency in others. Accessibility signage criteria have been established for the physically challenged. These include mounting heights, contrast and finish, raised and Braille characters and pictograms, and character proportions and heights. It is recommended that compliant signage be installed throughout the building.

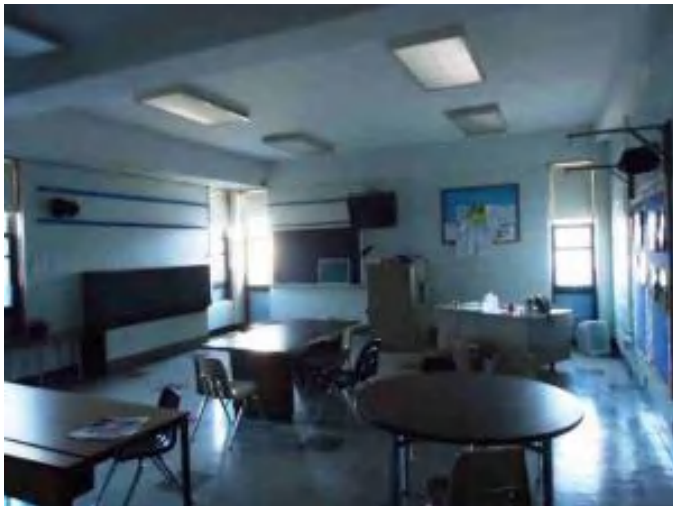
Location: Building Wide

System: C3020413 - Vinyl Flooring

Distress: Damaged

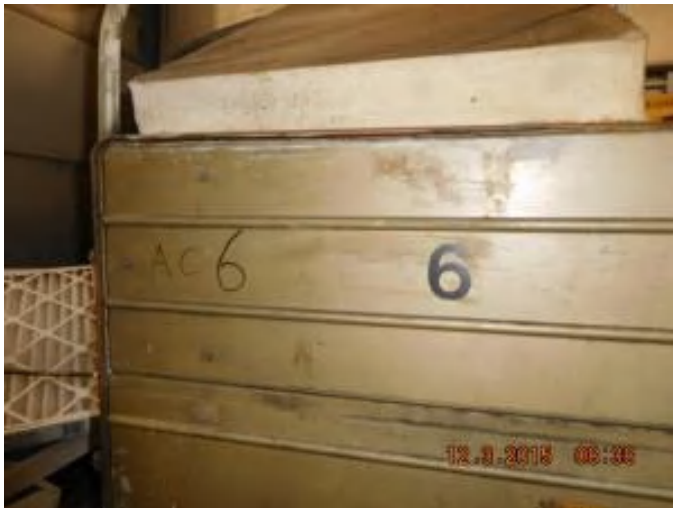
Location: IMC

System: D3040 - Distribution Systems

Distress: Building / MEP Codes

Notes: Remove existing and provide a new central station air handling unit for the IMC area with hot and chilled water coils, filters, outside and return air dampers, hydronic valves and controls, blower and motor. Connect to hot and chilled water systems. Include electrical connections.

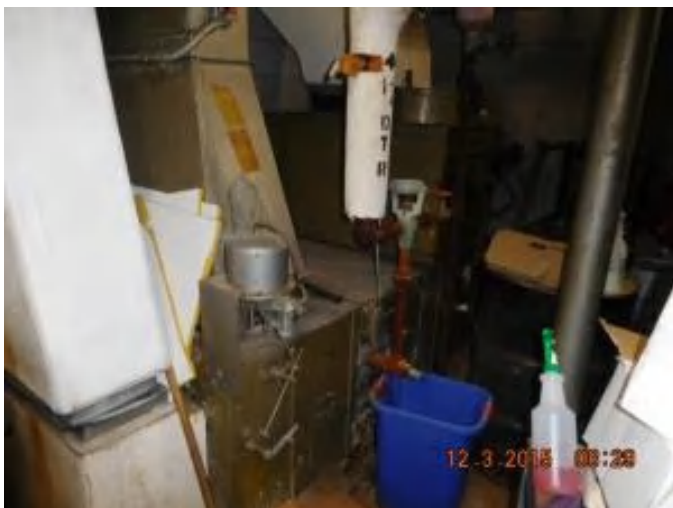
Location: office area

System: D3040 - Distribution Systems

Distress: Building / MEP Codes

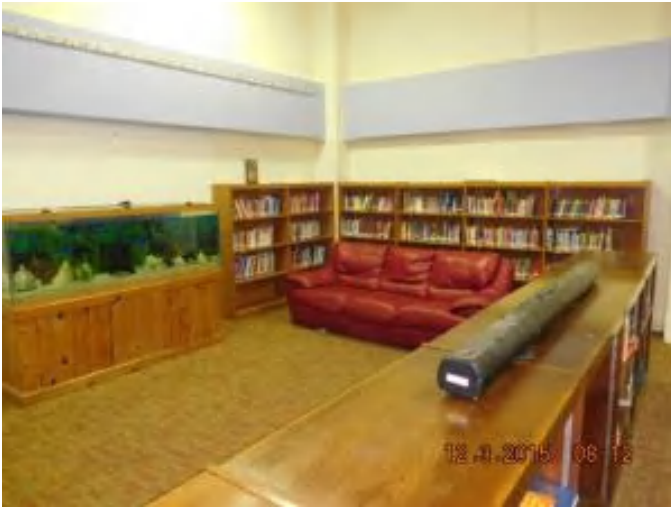
Location: entire building

System: D4010 - Sprinklers

Distress: Life Safety / NFPA / PFD

Notes: Install complete NFPA wet pipe automatic sprinkler system and standpipes in areas not protected. If required provide fire pump and jockey pump with controller.

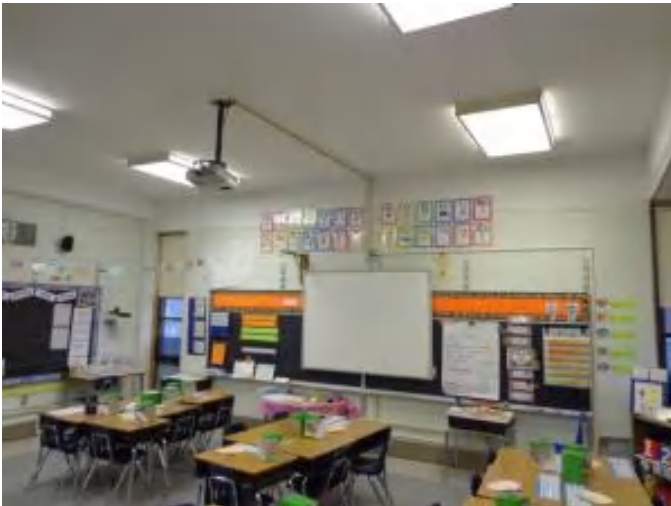
Location: Classrooms

Receptacles-- Classrooms typically are not provided with an adequate number of receptacles. It is recommended that 4 to 6 additional duplex receptacles be provided in 26 classrooms using a metal surface raceway system. Because of the age of the wiring devices and branch circuit wiring, replacement of all receptacles in the building is included in this report (estimate of 150 duplex receptacles).

System: D5020 - Lighting and Branch Wiring

Distress: Inadequate

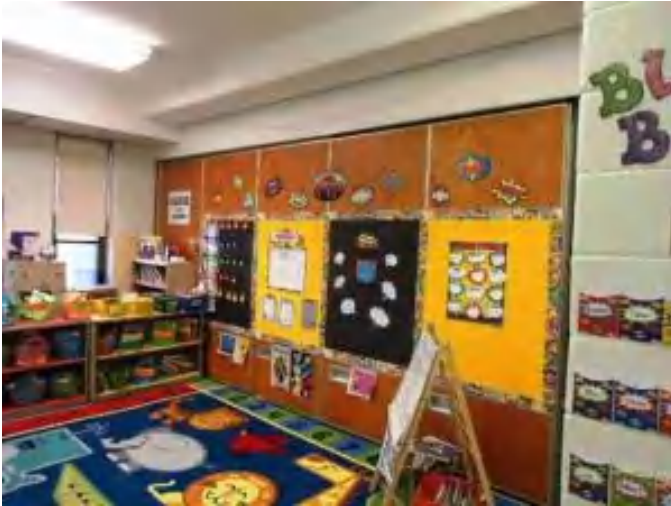
Location: Classrooms

There are several movable partitions that remain in classrooms. These wall systems are no longer used and in most cases cannot be used due to damage or wall modifications to support classroom needs. This deficiency provides a budgetary consideration to remove and replace the wall systems with universal removal of the existing movable partitions and upgrades to a permeate wall systems.

System: C1010 - Partitions

Distress: Damaged

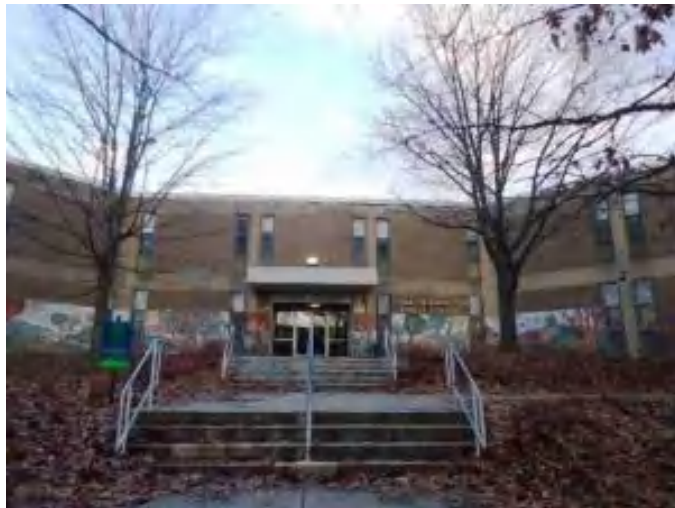
Location: Visitor Entrance

System: D5030 - Communications and Security

Distress: Inadequate

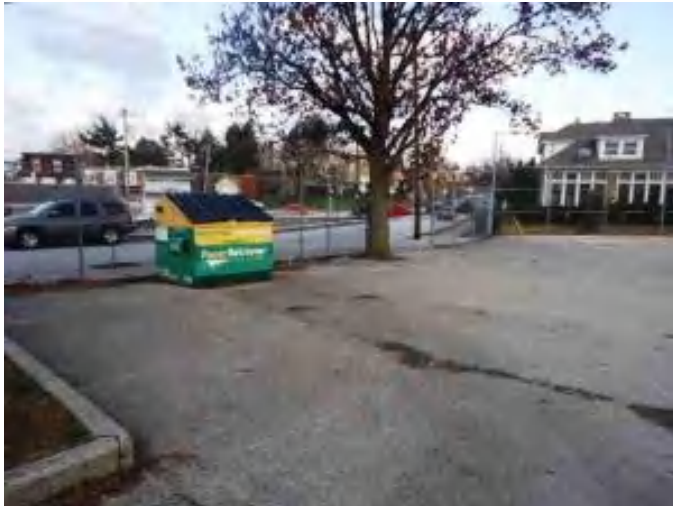
Location: Site

System: G2040 - Site Development

Distress: Health Hazard / Risk

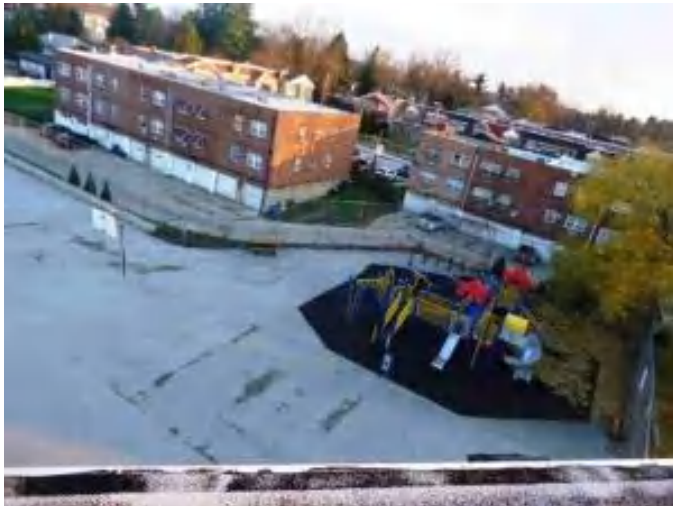
Location: Site

System: G2020 - Parking Lots

Distress: Damaged
