# Hamilton Disston Elementary School

## Major Renovation & Addition Scope of Work

Rev. July 24, 2020

School District of Philadelphia  
Office of Capital Programs  
440 North Broad Street  
Philadelphia, PA 19130

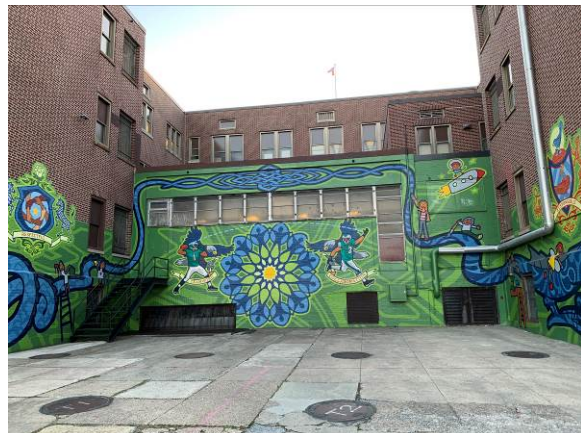
Condition: The existing play area surface and building yard of approximately 32,566 square feet is made up of concrete squares, some of which have completely cracked and pose a tripping hazard. It appears that individual replacements of damaged squares has taken place over time. Currently there is not a separation between the yard area that has access to manholes, the access drive, and the designated play area. The rear yard area is also where early grade children line up to enter the building every morning. The current facilities maintenance Work Request Report lists open maintenance items of surface damage and tripping hazards across the existing surface.

Courtyard with manhole access

Recommendation: Replace sections of concrete that are beyond repair. A renovated yard and play area should be planned to incorporate a building addition and provide separation of a lineup/ play area from all building infrastructure access and trash and waste storage. The new design should consider how surface areas can better meet the sidewalk grade and eliminate or minimize the need for stairs and ramps.

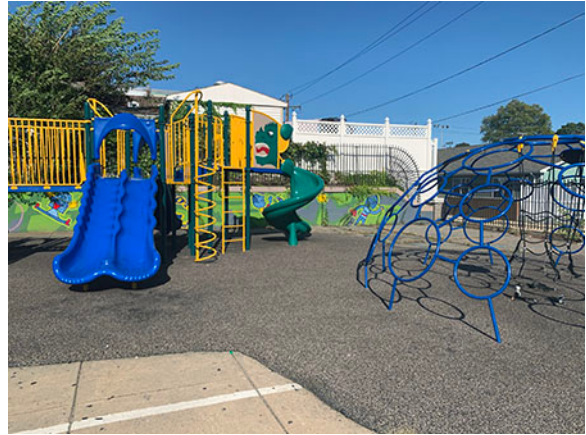
Condition: There is existing play equipment that is relatively new and in good condition. However the safety surface has significant holes. There are new metal benches and a few aged, damaged, concrete tables. The entire play area is open to community access and use at all times.

**Playground Equipment**

Recommendation: Play area surface should be replaced, and the equipment re-installed at completion. The bench locations should be reconsidered as part of the building

alteration and addition planning. The building currently makes the play area available to the public, and that condition is expected to be maintained.

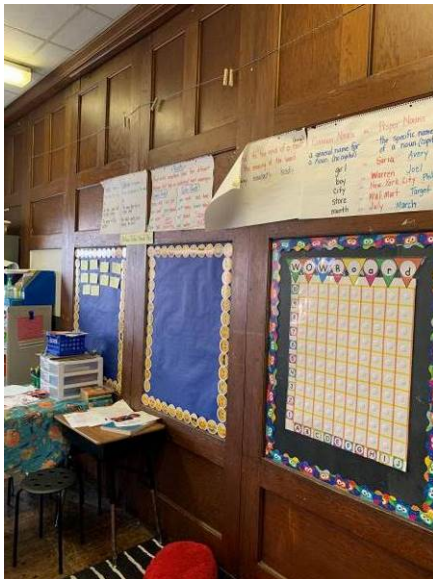
Condition: Interior partitions throughout the upper three floors are plaster on lath or are terracotta. There is some surface cracking and damage of the walls at traffic areas near doorways and corners. The areas behind existing blackboards, whiteboards, projections screens, and other surface mounted furnishings should be assumed to be aged, and in need of plaster repair and refinishing. Some walls in the basement level are brick masonry. Wall base, window sills and frames, and ceiling trim are all stained wood. Dividers exist between groups of rooms that are wood panels.

Wood Panel Divider

Recommendation: Plaster walls should be reinforced/ protected at high traffic areas. Remove all miscellaneous fasteners and obsolete equipment. Plaster or gypsum walls should have the surface repaired and be repainted. The wood panel systems dividing rooms should be eliminated to either increase the size of existing classrooms or be replaced with a fixed stud- wall partition. Terracotta walls should be repaired or repointed where necessary.

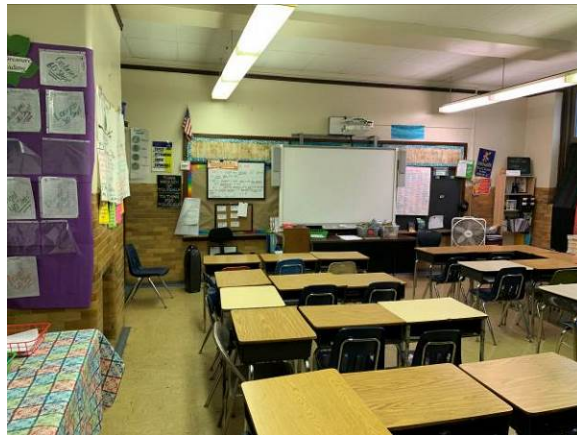
Typical Classroom

Condition: Most classrooms on building levels 1-3 have solid wood floors that are worn. Some early grade rooms have area rugs. Rooms on the basement level are 12x12 VCT or concrete. Some rooms throughout are recorded to have 9x9 VAT floor tile. Floors in the storage closets are often tile.

Condition: Most classroom ceilings are suspended 2x4 ACT hung between the concrete structural beams. Some are aged, others are in fair condition. In many rooms the ceilings have been hung below the existing window openings. Lighting in some rooms are 2x4 troffers, others 1x4 surface mounted. The condition above the suspended ceiling could not be observed. Not every classroom was surveyed. Rooms without suspended ceilings are constructed of plaster and assumed to require minor patching or repair.

Recommendation: All wood floors should be sanded, any repairs made, and refinished. VCT floors should be replaced, and all VAT floors shall be abated and replaced with VCT or similar resilient flooring.

Recommendation: Replace the existing suspended ceiling system. Install new suspended ceiling system in all classrooms, offices, hallways, IMC space and the computer lab.

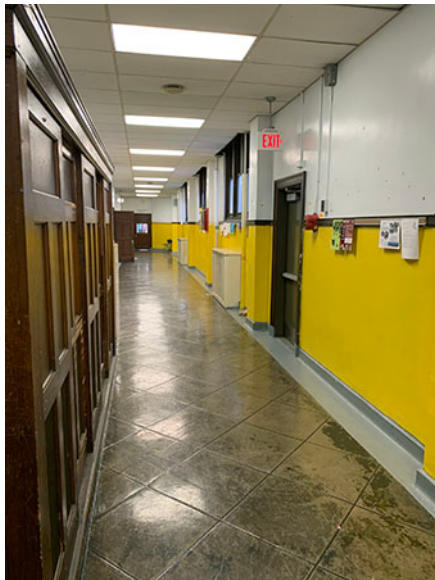
Typical Corridor

**Condition:** The floors in the corridors are stamped concrete that are aged but most show only minor surface wear. The walls are plaster with concrete bases that have dark wood trim and tack areas. All wall components are in good condition. Doorways to most rooms are wood doors and trim where most are damaged beyond just finish. Some door hardware has been replaced over time but is mostly aged brass. The ceilings in the corridors are acoustical ceiling tiles with troffer lighting. These ceilings are aged and yellowed, and are suspended below the window heads. Existing exit signs are hung from the ceiling and only some still illuminate. There is missing or worn lettering stenciled to designate rooms. There is signage designating the building as a "Fallout shelter." The fire alarm is of antiquated design. Some halls have storage cabinets constructed within that are underutilized. On the basement level finishes are in good condition, however there is large scale ventilation ductwork that is not currently utilized by the building and dominates the overhead space.

**Recommendation:** Refinish all concrete floors, patch and repair walls. All interior doors and hardware should be replaced as part of making accessibility and egress upgrades to the building. All suspended ceilings in the corridors should be either exposed and repaired or replaced with new cloud acoustical ceiling treatment. All halls should receive new code compliant exit signage and fire alarm devices. New ADA compliant room signage should be posted at each doorway, and fallout shelter signage removed. Damaged pipe insulation should be replaced as part of the mechanical scope. Storage constructed in the hallways should be removed. Fire extinguishers should be set in proper cases. Display space and tack areas should be coordinated to create designated locations for each room. In the basement the main issue to address is the ceiling. If possible a new building ventilation system should either eliminate or downscale the existing ductwork as part making the entire basement level finished, usable space.

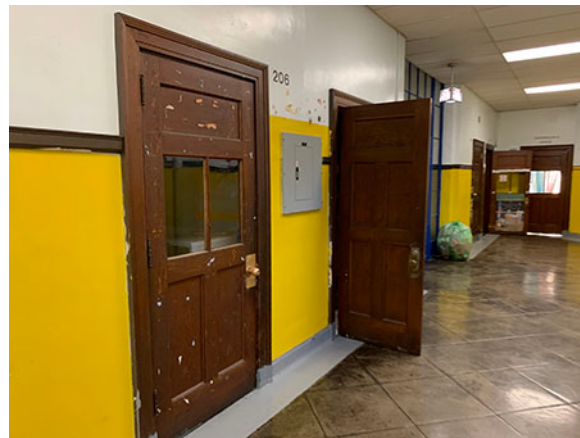
Typical Interior Doors

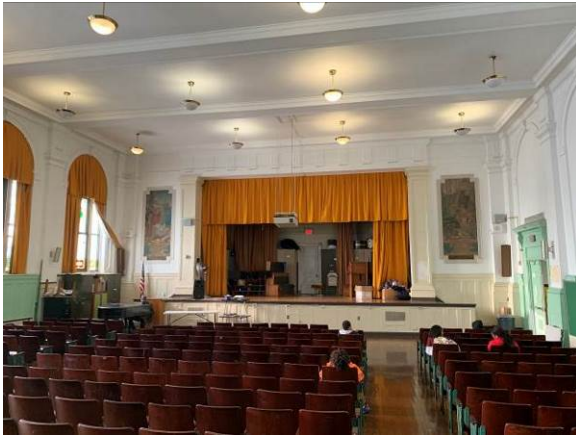
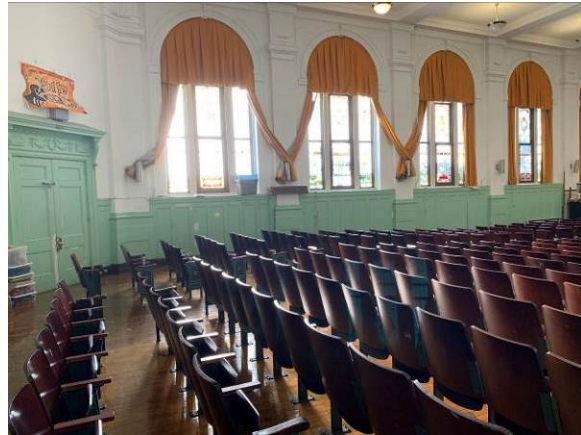
**Auditorium**

**Condition:** The first floor assembly room is a dramatic two-story space of approximately 3400 S.F. At one end there is a raised stage that can be accessed from a stair within the room or by an entrance at the rear of the stage. There is ventilation and lighting within the base of the stage. The stage and the room has wood floors and plaster walls. The floors are surface worn and the plaster has minor damage at some locations. The ceiling is also plaster and shows some evidence of localized surface damage. There are about 385 fixed wooden chairs that are in good condition. There are large, bordered artwork panels adjacent to the stage and on the interior walls. The large, arched top windows have stained glass sections that should be maintained. There are storage cabinets along the outside wall that require minor repair. All exit doors show signs of recent work, however the rear exit does not have proper signage or hardware. Overhead lighting works to varying degree, and it was not apparent during the building visit the functionality of the wall sconces or the stage lighting. There are large window curtains and a stage curtain that appear aged.

**Recommendation:** This space should be restored, and updated with specific code compliance items and assembly functional needs. The wood floors should be sanded and refinished. Any damage to the plaster walls or ceiling should be patched and repaired. The rear exist that lead to a stairs should get a new code compliant handrail

and door hardware. The stained glass windows should be addressed separately from the rest of the building for repair and upgrading energy efficiency. HVAC work should include a new ventilation system. Lighting should be upgraded to improve control and efficiency. Stage lighting should also be added and replaced. The stairs leading from the stage to the audience area should be modified to have code compliant risers and handrails.

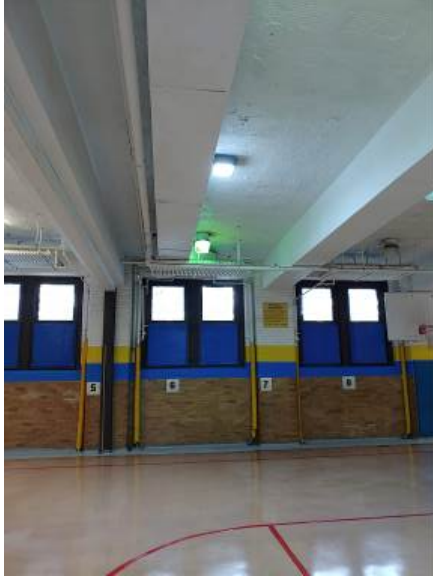
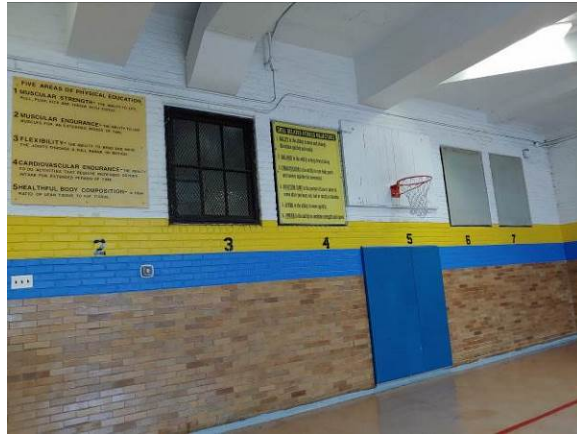
Gymnasium

Condition: The gymnasium is approximately 4,000 S.F., dividable, and located on the basement level. The floor is surfaced with VAT floor tile. The walls are painted and glazed brick that is in good condition. There are double hung- type windows with the lower half covered by safety mats that provide daylight. Room height is limited by overhead structure and steam radiators and associated piping. Signs and banners line the upper wall and often conceal windows that lead into the corridor. There are pull up bars and basketball backboards with hoops affixed to the walls for physical education. There is some padding mounted to the lower walls by the basketball hoops.

Recommendation: Abate all VAT floors and install new athletic surface striped per the district standards. The dividing partition should be demolished if it is not needed or doesn't work. The room should be provided with proper ventilation. The overhead piping and radiators should be replaced with a heating and cooling system that can fit tighter between the building structure. As part of the window replacement the gym windows should be replaced with units that have safety provision on the interior. Windows leading to the corridor should get proper safety attention so that the visible connection can be restored.

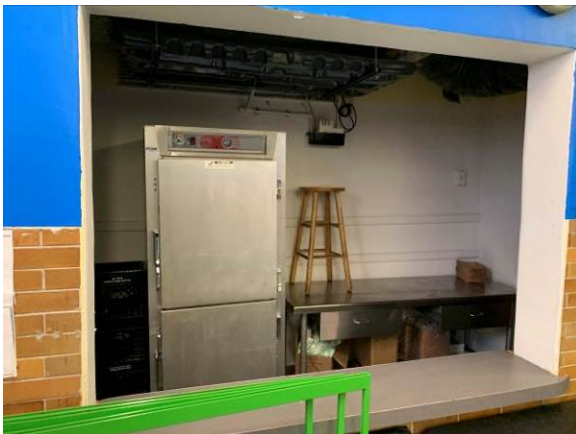
Condition: The existing cafeteria is about 1700 S.F. on the basement level. Food storage takes place down the hall in a former classroom, and the kitchen is sized just to heat and hand out food (250 S.F.) The walls are plaster over glazed brick, as is consistent in most rooms on the basement level. There are windows on the outside wall and the lower panels are infilled with spandrel panel. There is an acoustical ceiling between the concrete structural beams. Fluorescent lighting is suspended in the space. The floor is VCT that appears recent and in good condition. There are heating radiators on the outside wall as well as tubular ductwork below the ceiling. The original purpose of this space was two technology classrooms.

Heating/ Serving Window

Recommendation: The existing cafeteria is undersized and does not have adequate food preparation space. After repurposing the space the ceilings should be replaced and new lighting installed. Any piping or ductwork that is not part of a new HVAC system going forward should be eliminated.

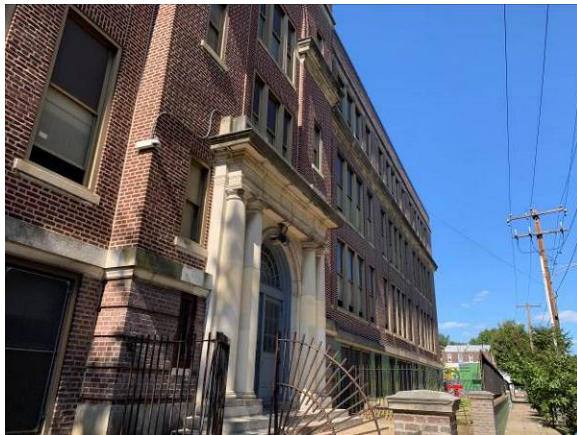
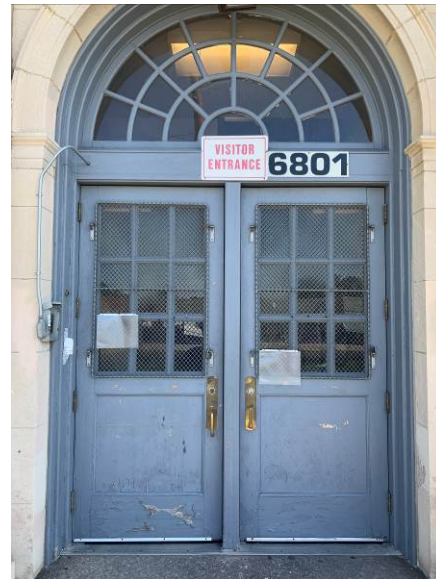
All other door exterior doorways are painted steel, primarily used for either emergency egress or access to and from the rear play yard. Most steel doors are in poor or worn condition.

Northeast Entry

Primary Entry

Recommendation: The primary entry should be accessible, and entry and circulation could be reconsidered when a building addition is constructed. The existing wood doorways should be restored, and hardware should be replaced. The School District’s new Access Control program should be implemented. New signage should be included clearly designating the visitor and accessible building entry. All steel doors, frames, and hardware should be replaced to meet current code and School District standards.

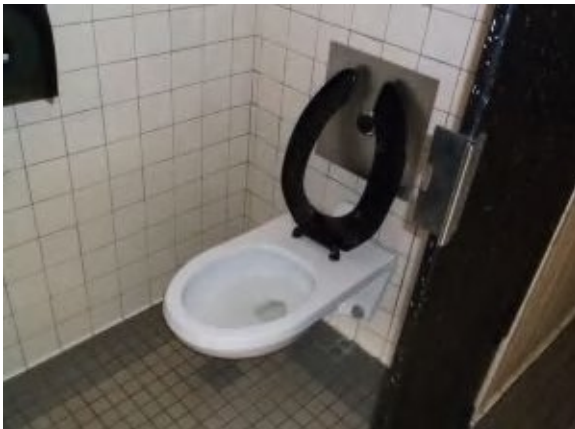
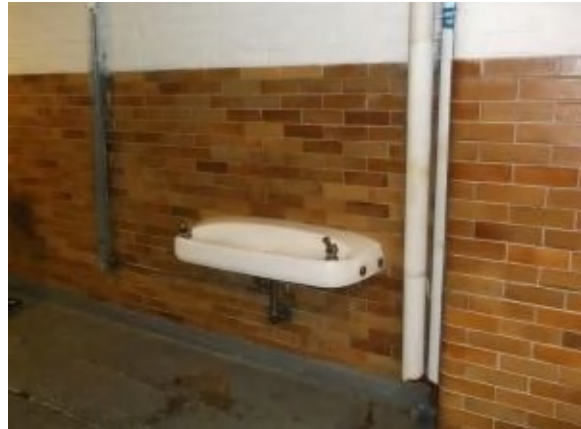
**Typical Water Closet**

**Typical Drinking Fountain**

1. Replace all lavatories in the building with low flow fixtures. Replace water closets and urinals as needed to supplement recent work so that all are new, low flow fixtures.
2. Replace the wall hung drinking fountains and integral refrigerated coolers in the corridors and at the restrooms with hydration stations.
3. Replace service sinks (janitor sinks) in the building.

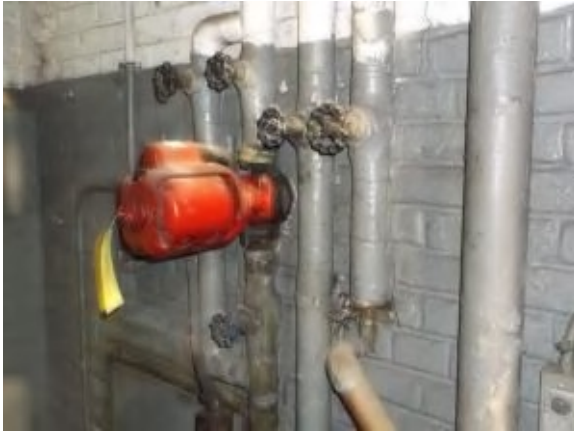
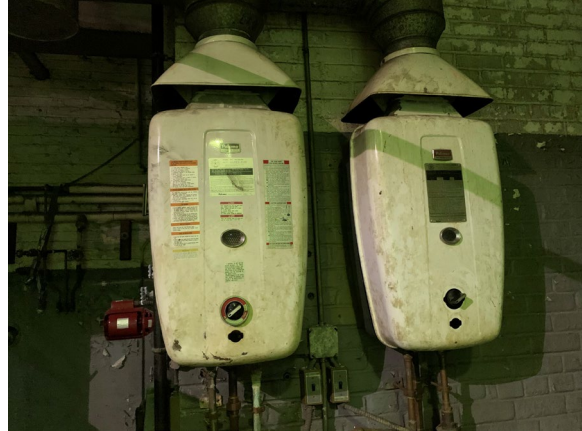
**Water System**

**Hot water system**

1. The distribution piping appears to be original and is at the end of its service life and is recommended to be inspected and repaired as needed. Confirm water pressure at building service entrance. Add booster pump for domestic water if required.
2. Replace two instantaneous natural gas fired tank-less water heaters with gas fired high efficiency condensing hot water heaters with direct ventilation.

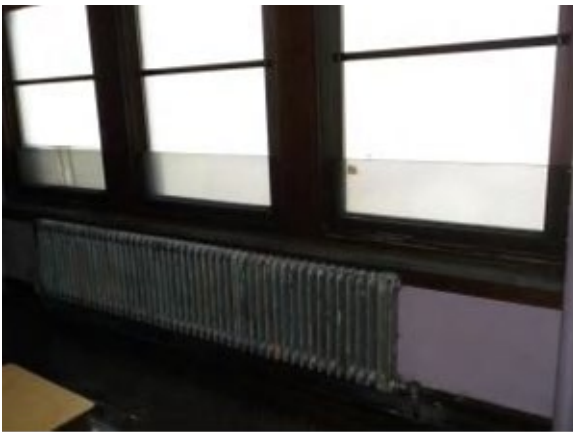
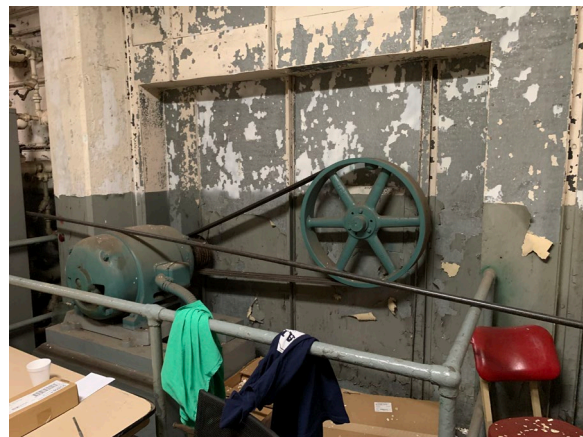
**Classroom Heating**

**Building House Fan**

5. All system associated with the existing kitchen shall be removed for the purpose of renovating and repurposing the space. Provide ventilation, heating and cooling for the Kitchen/Food Prep Area by removing the existing steam radiators and installing fan coil units with heating and cooling with a dedicated outside air ventilation system. Install new kitchen hood exhaust (CLASS I) and make up air systems. This is required for a full kitchen as requested. A new dishwasher exhaust hood of stainless steel (CLASS II) shall be furnished. The new kitchen hood shall have a fire suppression system integral with the hood.
6. The library packaged roof top shall be replaced with a similar sized system connected to the building's proposed new controls.
7. The DX unit over the auditorium should be serviced, and any necessary repairs made.

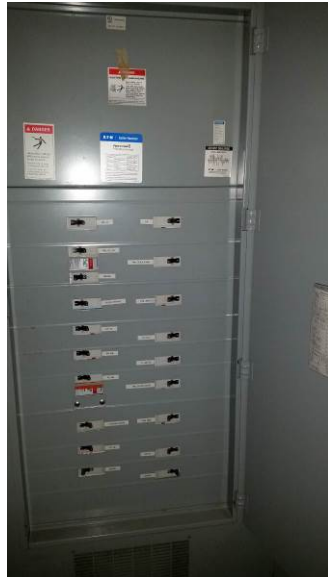
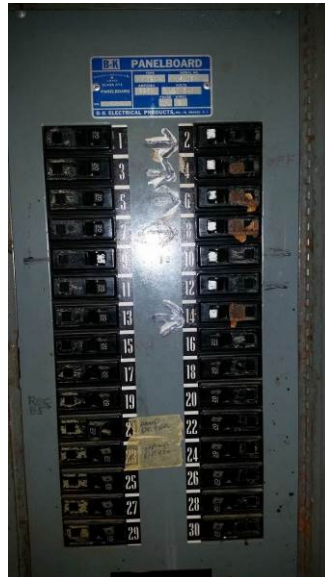
Electrical Service

Local Panel

1. Provide a new 3000A electrical service for all new loads and existing loads.
2. The existing main building 1200A electrical service equipment is in good condition and should be reconnected to the new 3000A electrical service.
3. Replace the antiquated panels on each floor. If the existing panel is flush mounted in the masonry wall then retrofit by reusing the existing panel boxes. If the existing panel is surface mounted then replace entire panel.
4. Provide more power receptacles in classrooms to meet the minimum classroom power receptacle layout.
5. Demolish window ACs after new chiller is operational and accepted by SDP.

6. Install new power feeds for proposed mechanical equipment. This would include all fan coil or ventilator units, new DOAS equipment, new chiller, and any other new exhaust or air handling units.

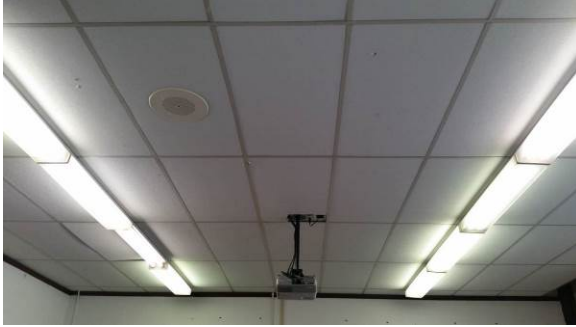
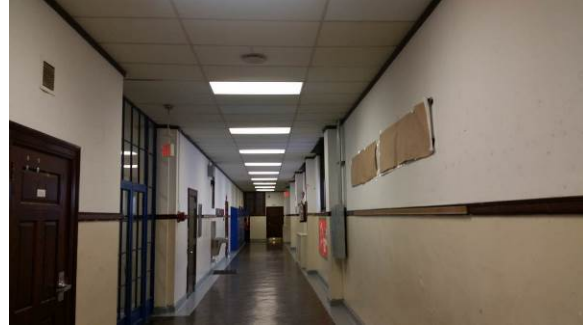
Typical Classroom Lighting

Typical Corridor Lighting

1. Replace existing interior and exterior lighting with LED lighting system.
2. Provide new lighting branch circuits if existing cannot be reused and reuse the existing conduits in good condition to the greatest extent possible.
3. Provide lighting control complying with the adopted Philadelphia energy code.
4. Provide occupancy sensors in each space and hallway for full coverage detection.
5. Exterior lights shall be factory equipped with photocells.
6. Replace exit signs with white thermoplastic LED type exit signs.
7. Connect emergency lights to the existing generator source.
8. Provide additional exterior wall mounted LED lights.
9. Design consultant shall provide floor plans, luminaire schedule and specifications.

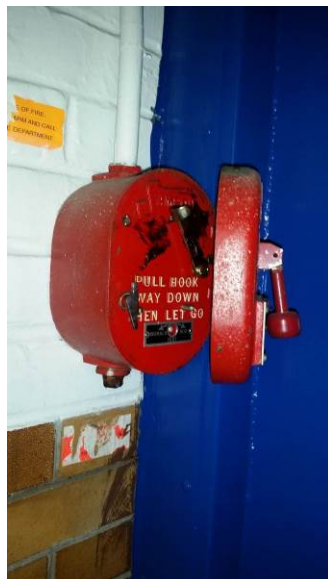
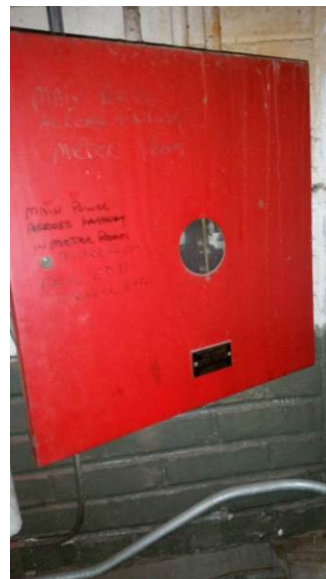
Typical Fire Alarm Device

Fire Alarm Panel

1. Provide a new fire alarm system per School District of Philadelphia fire alarm standard.
2. Design consultant shall provide floor plans, riser diagram and specifications.
3. Demolish the existing coded fire alarm system after acceptance of new fire alarm system.

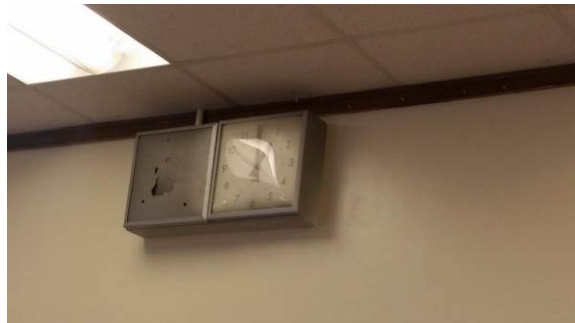
**Classroom Clock and PA**

1. Provide wireless clocks in classrooms, cafeteria, main office, common offices, gym, and auditorium. Provide wire guards where necessary.
2. The design consultant shall provide floor plans and specifications.
3. Remove the old clock system that is no longer functional.
